Access Compliance Report

Public Rights-of-Way

(Curb Ramps)

Intersection ID: 28355	Main Street: BRIDGE_CREEK_WY	Cross Street: BRIDGEHAMPTON CLUB DR	Location: NW
ADA ID: 4284A11AD83D	Ramp Type: Perp	Initial Pass/Fail: Fail	Overall Compliance: No
Severity Score: 21.25			
Codes/Mitigation Info/Possible Solution		Field Measurements/Component Compliance

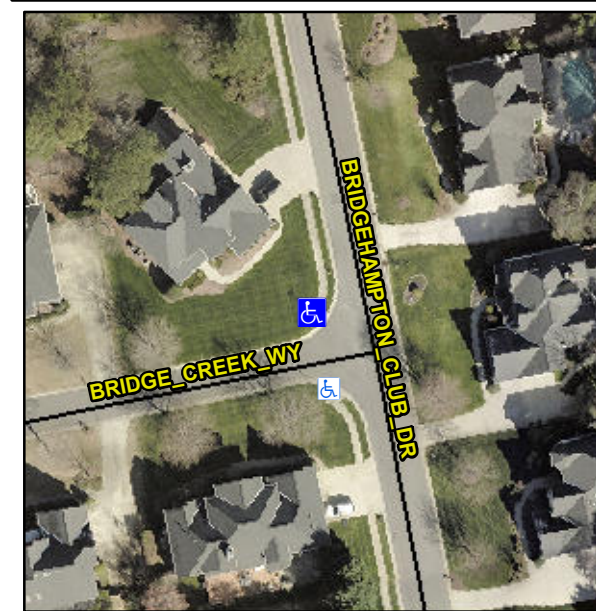
Not Found, R304.5.1, R304.2.2

Compliance	Description	Data	Compliance	Description	Data
N/A	Ramp Length (in)	47.5	No	Ramp Slope (%)	9.3
No	Ramp Width (in)	37.0	Yes	Ramp XSlope (%)	1.7
N/A	Flare Type LT	N/A	N/A	Flare Type RT	N/A
N/A	Flare Slope LT (%)	N/A	N/A	Flare Slope RT (%)	N/A
N/A	Flare Traversable LT?	N/A	N/A	Flare Traversable RT?	N/A
N/A	Landing Length (in)	N/A	N/A	DWS Provided?	N/A
N/A	Landing Width (in)	N/A	N/A	DWS Contrast?	N/A
N/A	Landing Slope (%)	N/A	N/A	DWS Length (in)	N/A
N/A	Landing X Slope (%)	N/A	N/A	DWS Full Width?	N/A
N/A	Landing Curb? (Y/N)	N/A	N/A	DWS Offset (in)	N/A
N/A	Shared Landing?	N/A			
N/A	Gutter Ponding?	N/A	N/A	Gutter Slope (%)	N/A
N/A	Gutter Lip Ht (in)	N/A	N/A	Gutter X Slope (%)	N/A
N/A	Painted X Walk1?	No	N/A	Painted X Walk2?	N/A
	X Walk 1 Direction	To S		X Walk 2 Direction	N/A
N/A	X Walk 1 Width (in)	N/A	N/A	X Walk 2 Width (in)	N/A
	X Walk 1 Slope (%)	6.7		X Walk 2 Slope (%)	N/A
	X Walk 1 X Slope (%)	4.4		X Walk 2 X Slope (%)	N/A

N/A	Ramp inside XWalk1?	N/A	N/A	Ramp inside XWalk2?	N/A
	Road Slope (%)	N/A	N/A	Clear Space?	N/A
	Road X Slope (%)	N/A	N/A	Clear Space to XWalk (in)	N/A
N/A	Any Obstructions?	N/A	N/A	Storm Grate/Utility Hazard?	N/A
	Obstruction Type			Storm Grate/Utility Type	
		N/A			N/A
			Yes	Surface Condition? (G/P)	Good

Possible Solutions:

Remove & Replace Entire Ramp.

Total Cost: \$ 1850.00
