Access Compliance Report

Public Rights-of-Way

(Curb Ramps)

Intersection ID: 13036	Main Street: CHATHAM_AV	Cross Street: ROLAND_ST	Location: NW
ADA ID: 42862A98DEF8	Ramp Type: Perp	Initial Pass/Fail: Fail	Overall Compliance: No
Severity Score: 8.75			
Codes/Mitigation Info/Possible Solution		Field Measurements/Component Compliance

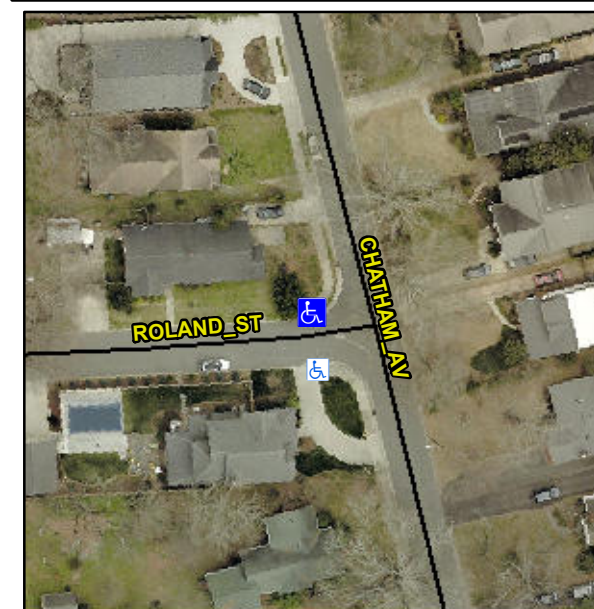
Not Found, R304.5.1

Compliance	Description	Data	Compliance	Description	Data
N/A	Ramp Length (in)	25.0	Yes	Ramp Slope (%)	7.0
No	Ramp Width (in)	47.0	Yes	Ramp XSlope (%)	0.8
N/A	Flare Type LT	N/A	N/A	Flare Type RT	N/A
N/A	Flare Slope LT (%)	N/A	N/A	Flare Slope RT (%)	N/A
N/A	Flare Traversable LT?	N/A	N/A	Flare Traversable RT?	N/A
N/A	Landing Length (in)	N/A	N/A	DWS Provided?	N/A
N/A	Landing Width (in)	N/A	N/A	DWS Contrast?	N/A
N/A	Landing Slope (%)	N/A	N/A	DWS Length (in)	N/A
N/A	Landing X Slope (%)	N/A	N/A	DWS Full Width?	N/A
N/A	Landing Curb? (Y/N)	N/A	N/A	DWS Offset (in)	N/A
N/A	Shared Landing?	N/A			
N/A	Gutter Ponding?	Yes	N/A	Gutter Slope (%)	N/A
N/A	Gutter Lip Ht (in)	N/A	N/A	Gutter X Slope (%)	N/A
N/A	Painted X Walk1?	No	N/A	Painted X Walk2?	N/A
	X Walk 1 Direction	To S		X Walk 2 Direction	N/A
N/A	X Walk 1 Width (in)	N/A	N/A	X Walk 2 Width (in)	N/A
	X Walk 1 Slope (%)	0.5		X Walk 2 Slope (%)	N/A
	X Walk 1 X Slope (%)	0.4		X Walk 2 X Slope (%)	N/A

N/A	Ramp inside XWalk1?	N/A	N/A	Ramp inside XWalk2?	N/A
	Road Slope (%)	N/A	N/A	Clear Space?	N/A
	Road X Slope (%)	N/A	N/A	Clear Space to XWalk (in)	N/A
N/A	Any Obstructions?	N/A	N/A	Storm Grate/Utility Hazard?	N/A
	Obstruction Type			Storm Grate/Utility Type	
		N/A			N/A
		Yes		Surface Condition? (G/P)	Good

Remove & Replace Entire Ramp.

Total Cost: \$ 1850.00
