Access Compliance Report

Public Rights-of-Way

(Curb Ramps)

Intersection ID: 10022359	Main Street: CAMERON_VALLEY_PY	Cross Street: N/A	Location: SE
ADA ID: 428D476DBC14	Ramp Type: Directional1	Initial Pass/Fail: Fail	Overall Compliance: No
Severity Score: 1.25			
Codes/Mitigation Info/Possible Solution		Field Measurements/Component Compliance

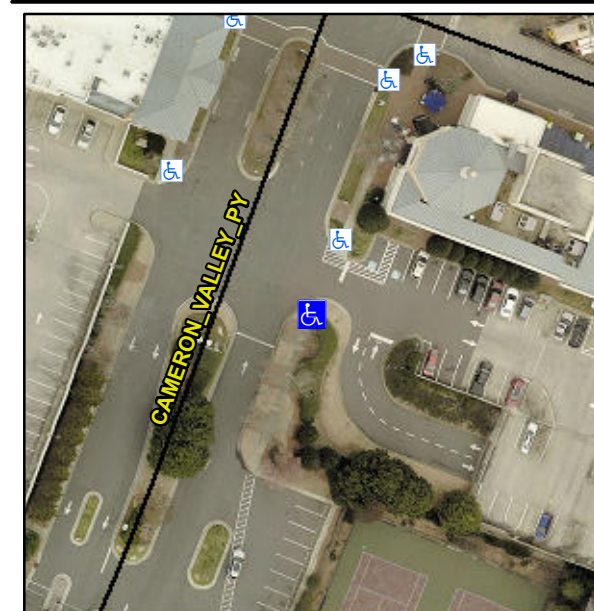
Compliance	Description	Data	Compliance	Description	Data
N/A	Ramp Length (in)	84.0	N/A	Grade Break?	N/A
Yes	Ramp Width (in)	61.0	N/A	Grade Break Slope (%)	0.0
Yes	Ramp Slope (%)	0.5	N/A	Grade Break XSlope (%)	0.0
No	Ramp XSlope (%)	3.8			
N/A	Flare Type LT	N/A	N/A	Flare Type RT	N/A
N/A	Flare Slope LT (%)	N/A	N/A	Flare Slope RT (%)	0.0
N/A	Flare Traversable LT?	N/A	N/A	Flare Traversable RT?	N/A
N/A	Landing Length (in)	0.0	N/A	DWS Provided?	N/A
N/A	Landing Width (in)	0.0	N/A	DWS Contrast?	N/A
N/A	Landing Slope (%)	0.0	N/A	DWS Length (in)	N/A
N/A	Landing X Slope (%)	0.0	N/A	DWS Full Width?	N/A
N/A	Landing Curb? (Y/N)	N/A	N/A	DWS Offset LT (in)	N/A
N/A	Shared Landing?	N/A	N/A	DWS Offset RT (in)	N/A
N/A	Gutter Ponding?	0.0	N/A	Gutter Slope (%)	N/A
N/A	Gutter Lip Ht (in)	0.0	N/A	Gutter X Slope (%)	N/A
N/A	Painted X Walk1?	No		Road Slope (%)	2.7
	X Walk 1 Direction	To N		Road X Slope (%)	1.8
	X Walk 1 Width (in)	N/A		Clear Space?	N/A

X Walk 1 Slope (%)	2.7	N/A	Clear Space to XWalk (in)	N/A
	X Walk 1 X Slope (%)	1.8	N/A	Storm Grate/Utility Hazard?	N/A
N/A	Ramp inside XWalk1?	N/A		Storm Grate/Utility Type	
N/A	Any Obstructions?	N/A			N/A
	Obstruction Type		Yes	Surface Condition? (G/P)	Good
			N/A	Curb Slope (%)	6.8

Possible Solutions:

Remove & Replace Entire Ramp.

R304.5.3

\$ 1600.00
