# Access Compliance Report

## Public Rights-of-Way

### (Curb Ramps)

Intersection ID: 27404	Main Street: BALLANTYNE COMMONS PY	Cross Street: MEADOW RUN LN	Location: NE
ADA ID: 428E23A1CFD0	Ramp Type: Perp	Initial Pass/Fail: Fail	Overall Compliance: No
Severity Score: 21.25			
Codes/Mitigation Info/Possible Solution		Field Measurements/Component Compliance

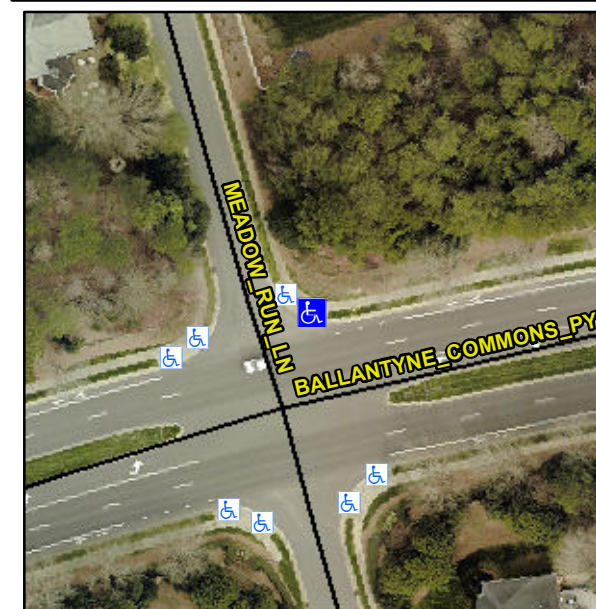
**Not Found, R304.5.1, R304.2.2**

Compliance	Description	Data	Compliance	Description	Data
N/A	Ramp Length (in)	47.0	No	Ramp Slope (%)	10.9
No	Ramp Width (in)	45.0	Yes	Ramp XSlope (%)	0.7
N/A	Flare Type LT	N/A	N/A	Flare Type RT	N/A
N/A	Flare Slope LT (%)	N/A	N/A	Flare Slope RT (%)	N/A
N/A	Flare Traversable LT?	N/A	N/A	Flare Traversable RT?	N/A
N/A	Landing Length (in)	N/A	N/A	DWS Provided?	N/A
N/A	Landing Width (in)	N/A	N/A	DWS Contrast?	N/A
N/A	Landing Slope (%)	N/A	N/A	DWS Length (in)	N/A
N/A	Landing X Slope (%)	N/A	N/A	DWS Full Width?	N/A
N/A	Landing Curb? (Y/N)	N/A	N/A	DWS Offset (in)	N/A
N/A	Shared Landing?	N/A			
N/A	Gutter Ponding?	N/A	N/A	Gutter Slope (%)	N/A
N/A	Gutter Lip Ht (in)	N/A	N/A	Gutter X Slope (%)	N/A
N/A	Painted X Walk1?	No	N/A	Painted X Walk2?	N/A
	X Walk 1 Direction	To SE		X Walk 2 Direction	N/A
N/A	X Walk 1 Width (in)	N/A	N/A	X Walk 2 Width (in)	N/A
	X Walk 1 Slope (%)	0.5		X Walk 2 Slope (%)	N/A
	X Walk 1 X Slope (%)	0.8		X Walk 2 X Slope (%)	N/A

N/A	Ramp inside XWalk1?	N/A	N/A	Ramp inside XWalk2?	N/A
	Road Slope (%)	N/A	N/A	Clear Space?	N/A
	Road X Slope (%)	N/A	N/A	Clear Space to XWalk (in)	N/A
N/A	Any Obstructions?	N/A	N/A	Storm Grate/Utility Hazard?	N/A
	Obstruction Type			Storm Grate/Utility Type	
		N/A			N/A
			Yes	Surface Condition? (G/P)	Good

**Remove & Replace Entire Ramp.**
