Access Compliance Report Public Rights-of-Way (Curb Ramps)

Intersection ID: 16540 Main Street: CEDAR_TREE_LN Cross Street: CHESTNUT_LAKE_DR Location: NW Initial Pass/Fail: Fail ADA ID: 4291F72BC61D Ramp Type: Perp **Overall Compliance: No Severity Score:** 50

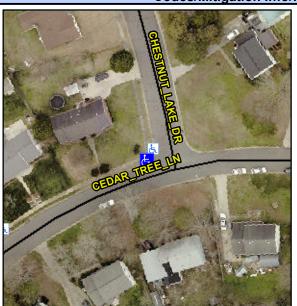
Field Measurements/Component Compliance								
Compl	iance Description	Data	Compl	iance	Description	Data		
N/A	Ramp Length (in)	95.0	No	Ramp	o Slope (%)	13.7		
Yes	Ramp Width (in)	48.0	No	Ramp	xSlope (%)	7.2		
N/A	Flare Type LT	N/A	N/A	Flare	Type RT	N/A		
N/A	Flare Slope LT (%)	N/A	N/A	Flare	Slope RT (%)	N/A		
N/A	Flare Traversable LT?	N/A	N/A	Flare	Traversable RT?	N/A		
N/A	Landing Length (in)	N/A	N/A	DWS	Provided?	N/A		
N/A	Landing Width (in)	N/A	N/A	DWS	Contrast?	N/A		
N/A	Landing Slope (%)	N/A	N/A	DWS	Length (in)	N/A		
N/A	Landing X Slope (%)	N/A	N/A	DWS	Full Width?	N/A		
N/A	Landing Curb? (Y/N)	N/A	N/A	DWS	Offset (in)	N/A		
N/A	Shared Landing?	N/A						
N/A	Gutter Ponding?	N/A	N/A	Gutte	er Slope (%)	N/A		
N/A	Gutter Lip Ht (in)	0.5	N/A	Gutte	er X Slope (%)	N/A		
N/A	Painted X Walk1?	No	N/A	Paint	ed X Walk2?	N/A		
	X Walk 1 Direction	To S		X Wa	lk 2 Direction	N/A		
N/A	X Walk 1 Width (in)	N/A	N/A	X Wa	ılk 2 Width (in)	N/A

X Walk 1 Slope (%)	1.8		X Wa	ılk 2 Slope (%)	N/A		
	X Walk 1 X Slope (%)	1.2		X Wa	ılk 2 X Slope (%)	N/A		
N/A	Ramp inside XWalk1?	N/A	N/A	Ram	p inside XWalk2?	N/A		
	Road Slope (%)	N/A	N/A	Clear	Space?	N/A		
	Road X Slope (%)	N/A	N/A	Clear	Space to XWalk (in)	N/A		
N/A	Any Obstructions?	N/A	N/A	Storn	n Grate/Utility Hazard?	N/A		
	Obstruction Type			Storn	n Grate/Utility Type			
		N/A				N/A		
			Yes	Surfa	ice Condition? (G/P)	Good

1 COCIDIO COIGUIOII		
Possible Solutions:	<u>c</u>	
Remove & Replace Entire Ramp.		
	Ye	
	N/	
	N	
	N	
	N	
Surveyor Notes:	N	
N/A	N	
	N	
	N	
	N	
PROW/ADA:	N	
R304.2.2, R304.5.3	N/	
•	N	
	N

Total Cost: 1850.00
