Access Compliance Report

Public Rights-of-Way

(Curb Ramps)

Intersection ID: 7779	Main Street: FRIENDLY_PL	Cross Street: MARCUS_CT	Location: S
ADA ID: 42A5333E3F7F	Ramp Type: BlendTrans1	Initial Pass/Fail: Fail	Overall Compliance: No
		Severity Score: 8.75

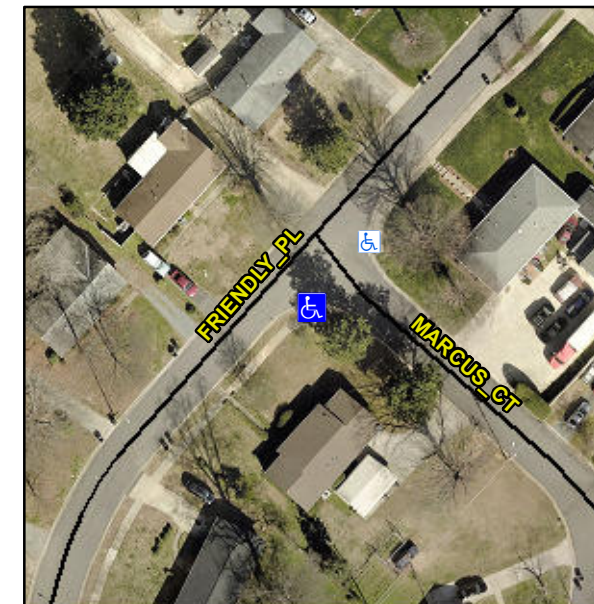
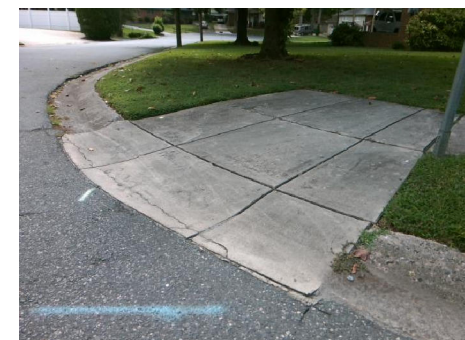
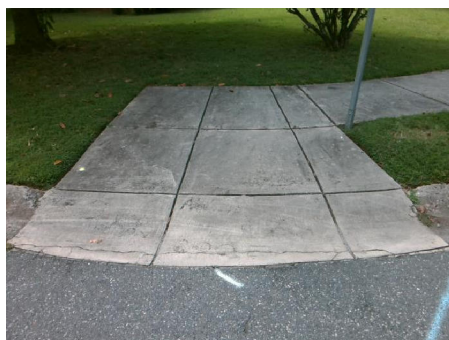
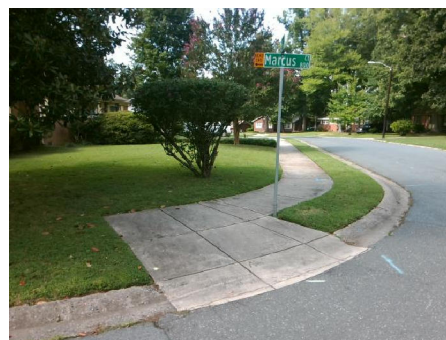
Not Found, R304.5.1

Compliance	Description	Data	Compliance	Description	Data
N/A	Ramp Length (in)	46.5	Yes	BlendTrans Slope (%)	4.8
No	Ramp Width (in)	38.5	Yes	BlendTrans XSlope (%)	1.7
N/A	Flare Type LT	N/A	N/A	Flare Type RT	N/A
N/A	Flare Slope LT (%)	N/A	N/A	Flare Slope RT (%)	N/A
N/A	Flare Traversable LT?	N/A	N/A	Flare Traversable RT?	N/A
N/A	Landing Length (in)	N/A	N/A	DWS Provided?	N/A
N/A	Landing Width (in)	N/A	N/A	DWS Contrast?	N/A
N/A	Landing Slope (%)	N/A	N/A	DWS Length (in)	N/A
N/A	Landing X Slope (%)	N/A	N/A	DWS Full Width?	N/A
N/A	Landing Curb? (Y/N)	N/A	N/A	DWS Offset (in)	N/A
N/A	Shared Landing?	N/A			
N/A	Gutter Ponding?	N/A	N/A	Gutter Slope (%)	N/A
N/A	Gutter Lip Ht (in)	N/A	N/A	Gutter X Slope (%)	N/A
N/A	Painted X Walk1?	No	N/A	Painted X Walk2?	N/A
	X Walk 1 Direction	To NE		X Walk 2 Direction	N/A
	X Walk 1 Width (in)	N/A		X Walk 2 Width (in)	N/A
	X Walk 1 Slope (%)	2.9		X Walk 2 Slope (%)	N/A
	X Walk 1 X Slope (%)	2.6		X Walk 2 X Slope (%)	N/A

N/A	Ramp inside XWalk1?	N/A	N/A	Ramp inside XWalk2?	N/A
	Road Slope (%)	2.6		Clear Space?	N/A
	Road X Slope (%)	2.9	N/A	Clear Space to XWalk (in)	N/A
N/A	Any Obstructions?	N/A	N/A	Storm Grate/Utility Hazard?	N/A
	Obstruction Type			Storm Grate/Utility Type	
		N/A			N/A
			Yes	Surface Condition? (G/P)	Good
			No	Curb Slope (%)	19.0

Remove & Replace Curb Ramp With Two New Directional Ramps or Equivalent.
