Access Compliance Report Public Rights-of-Way (Curb Ramps)

Intersection ID: 17555 Main Street: E_WOODLAWN_RD Cross Street: OLD_PINEVILLE_RD Location: NW **Overall Compliance: No** ADA ID: 42AA90353E73 Ramp Type: Para Initial Pass/Fail: Fail **Severity Score:** 25

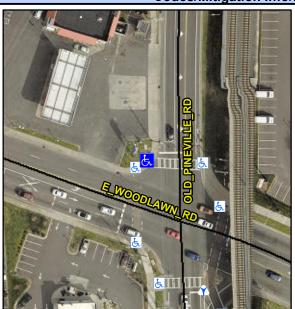
Field Measurements/Component Compliance							
Compliance Description		Data	Comp	liance Description	Data		
N/A	Ramp Length LT (in)	68.0	N/A	Ramp Length RT (in)	48.0		
Yes	Ramp Width LT (in)	71.0	Yes	Ramp Width RT (in)	71.0		
Yes	Ramp Slope LT (%)	1.6	No	Ramp Slope RT (%)	13.9		
Yes	Ramp XSlope LT (%)	0.4	Yes	Ramp XSlope RT (%)	0.2		
N/A	Landing Length (in)	N/A	N/A	DWS Provided?	N/A		
N/A	Landing Width (in)	N/A	N/A	DWS Contrast?	N/A		
N/A	Landing Slope (%)	N/A	N/A	DWS Length (in)	N/A		
N/A	Landing X Slope (%)	N/A	N/A	DWS Full Width?	N/A		
N/A	Landing Curb? (Y/N)	N/A	N/A	DWS Offset (in)	N/A		
N/A	Shared Landing?	N/A					
N/A	Gutter Ponding?	N/A	N/A	Gutter Slope (%)	N/A		
N/A	Gutter Lip Ht (in)	N/A	N/A	Gutter X Slope (%)	N/A		
N/A	Painted X Walk1?	No	N/A	Painted X Walk2?	N/A		
	X Walk 1 Direction	To E		X Walk 2 Direction	N/A		
N/A	X Walk 1 Width (in)	N/A	N/A	X Walk 2 Width (in)	N/A		
	X Walk 1 Slope (%)	2.5		X Walk 2 Slope (%)	N/A

X Walk 1 X Slope (%)	1.8		X Walk 2 X Slope (%)	N/A		
N/A	Ramp inside XWalk1?	N/A	N/A	Ramp inside XWalk2?	N/A		
	Road Slope (%)	N/A	N/A	Clear Space?	N/A		
	Road X Slope (%)	N/A	N/A	Clear Space to XWalk (in)	N/A		
N/A	Any Obstructions?	N/A	N/A	Storm Grate/Utility Hazard?	N/A		
	Obstruction Type			Storm Grate/Utility Type			
		N/A			N/A		
			Yes	Surface Condition? (G/P)	Good		
			N/A	Curb Slope (%)	9.1		
47

CCCIDIC CCIALICII	
Possible Solutions:	Con
Remove & Replace Entire Ramp.	N/A
•	Yes
	Yes
	Yes
	N/A
	N/A
Surveyor Notes:	N/A
LT RP < 5%	N/A
	N/A
	N/A
	N/A
PROW/ADA:	N/A
R304.3.2	N/A
	N/A
	N/A
