## Access Compliance Report Public Rights-of-Way (Curb Ramps)

Intersection ID: 52450 Main Street: TRANQUIL\_OAK\_PL Cross Street: MOSS\_LN Location: NW

ADA ID: 42AAC7DBB106 Ramp Type: Directional1 Initial Pass/Fail: Fail Overall Compliance: No Severity Score: 12.5

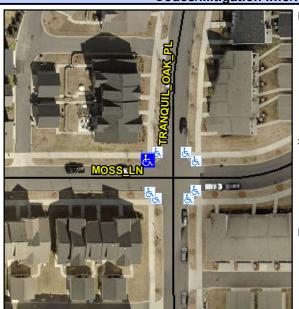
riola indudation							
Possible Solutions:	Compliance Description		Data	Compliance Description			
Remove & Replace Entire Ramp.	N/A	Ramp Length (in)	65.0	N/A	Grade Break?		
·	Yes	Ramp Width (in)	67.0	N/A	Grade Break Slope (%)		
	No	Ramp Slope (%)	9.1	N/A	Grade Break XSlope (%)		
	Yes	Ramp XSlope (%)	0.4				
	N/A	Flare Type LT	N/A	N/A	Flare Type RT		
	N/A	Flare Slope LT (%)	N/A	N/A	Flare Slope RT (%)		
Surveyor Notes:	N/A	Flare Traversable LT?	N/A	N/A	Flare Traversable RT?		
N/A	N/A	Landing Length (in)	0.0	N/A	DWS Provided?		
	N/A	Landing Width (in)	0.0	N/A	DWS Contrast?		
	N/A	Landing Slope (%)	0.0	N/A	DWS Length (in)		
	N/A	Landing X Slope (%)	0.0	N/A	DWS Full Width?		
PROW/ADA:	N/A	Landing Curb? (Y/N)	N/A	N/A	DWS Offset LT (in)		
R304.2.2	N/A	Shared Landing?	N/A	N/A	DWS Offset RT (in)		
	N/A	Gutter Ponding?	0.0	N/A	Gutter Slope (%)		
	N/A	Gutter Lip Ht (in)	0.0	N/A	Gutter X Slope (%)		
	N/A	Painted X Walk1?	No		Road Slope (%)
