Access Compliance Report

Public Rights-of-Way

(Curb Ramps)

Intersection ID: 10661	Main Street: N_DAVIDSON_ST	Cross Street: E_28TH_ST	Location: E
ADA ID: 42AE73632EC9	Ramp Type: BlendTrans1	Initial Pass/Fail: Fail	Overall Compliance: No
Severity Score: 21.25			
Codes/Mitigation Info/Possible Solution		Field Measurements/Component Compliance

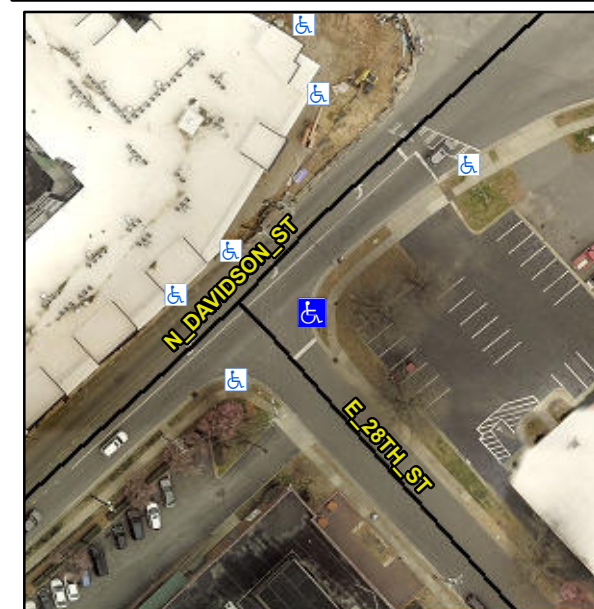
Not Found, R304.5.1, R304.5.3

Compliance	Description	Data	Compliance	Description	Data
N/A	Ramp Length (in)	78.0	Yes	BlendTrans Slope (%)	3.0
No	Ramp Width (in)	37.5	No	BlendTrans XSlope (%)	5.4
N/A	Flare Type LT	N/A	N/A	Flare Type RT	N/A
N/A	Flare Slope LT (%)	N/A	N/A	Flare Slope RT (%)	N/A
N/A	Flare Traversable LT?	N/A	N/A	Flare Traversable RT?	N/A
N/A	Landing Length (in)	N/A	N/A	DWS Provided?	N/A
N/A	Landing Width (in)	N/A	N/A	DWS Contrast?	N/A
N/A	Landing Slope (%)	N/A	N/A	DWS Length (in)	N/A
N/A	Landing X Slope (%)	N/A	N/A	DWS Full Width?	N/A
N/A	Landing Curb? (Y/N)	N/A	N/A	DWS Offset (in)	N/A
N/A	Shared Landing?	N/A			
N/A	Gutter Ponding?	N/A	N/A	Gutter Slope (%)	N/A
N/A	Gutter Lip Ht (in)	N/A	N/A	Gutter X Slope (%)	N/A
N/A	Painted X Walk1?	No	N/A	Painted X Walk2?	No
	X Walk 1 Direction	To NW		X Walk 2 Direction	To SW
	X Walk 1 Width (in)	N/A		X Walk 2 Width (in)	N/A
	X Walk 1 Slope (%)	3.0		X Walk 2 Slope (%)	2.5
	X Walk 1 X Slope (%)	2.9		X Walk 2 X Slope (%)	2.4

N/A	Ramp inside XWalk1?	N/A	N/A	Ramp inside XWalk2?	N/A
	Road Slope (%)	4.9		Clear Space?	N/A
	Road X Slope (%)	1.3	N/A	Clear Space to XWalk (in)	N/A
N/A	Any Obstructions?	N/A	N/A	Storm Grate/Utility Hazard?	N/A
	Obstruction Type			Storm Grate/Utility Type	
		N/A			N/A
			Yes	Surface Condition? (G/P)	Good
			No	Curb Slope (%)	17.4

Possible Solutions:

Remove & Replace Curb Ramp With Two New Directional Ramps or Equivalent.
