# Access Compliance Report

## Public Rights-of-Way (Curb Ramps)

| Intersection ID: 5481 | Main Street: MCCLURE_CR | Cross Street: PLEASANT_GROVE_RD | Location: | E |
| ADA ID: 42AFDE0DD3E3 | Ramp Type: Directional1 | Initial Pass/Fail: Pass | Overall Compliance: No | Severity Score: 10 |

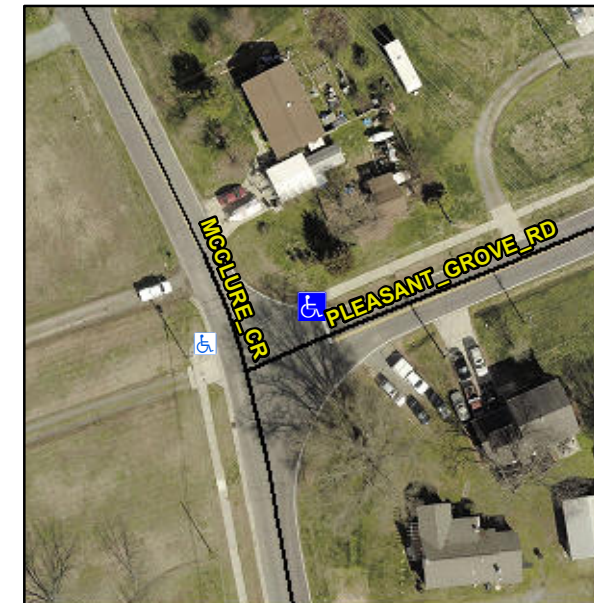
**NO CURB. DWS OS MEASURED TO  
ASP**

| Compliance | Description | Data | Compliance | Description | Data |
|---|---|---|---|---|---|
| Yes | Landing X Slope (%) | 0.5 | No | DWS Full Width? | No |
| N/A | Landing Curb? (Y/N) | No | No | DWS Offset LT (in) | 30.0 |
| N/A | Shared Landing? | No | No | DWS Offset RT (in) | 101.1 |
| No | Gutter Lip Ht (in) | 0.3 | Yes | Gutter X Slope (%) | 1.3 |

**Remove & Replace Detectable  
Warning System. Grind Gutter Lip.**

**R305.1.4, R305.2, R302.7.2**
