Access Compliance Report

Public Rights-of-Way

(Curb Ramps)

Intersection ID: 20760	Main Street: SHARON_RD	Cross Street: SHARON_VIEW_RD	Location: SE
ADA ID: 42B2A7FE5F9D	Ramp Type: Perp	Initial Pass/Fail: Fail	Overall Compliance: No
Severity Score: 12.5			
Codes/Mitigation Info/Possible Solution		Field Measurements/Component Compliance

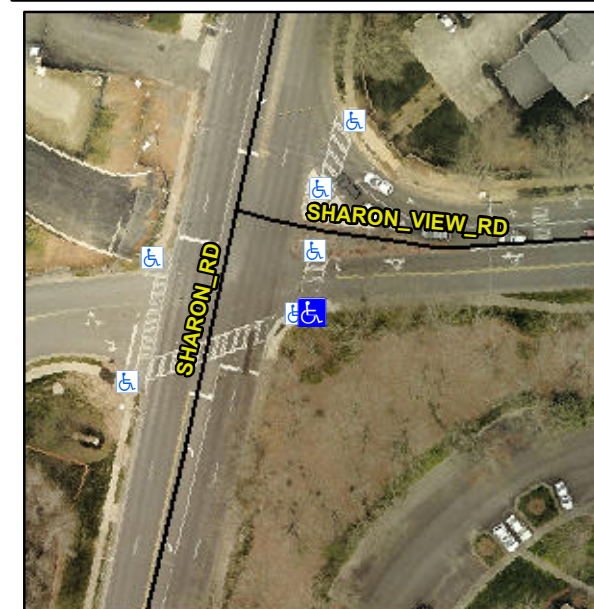
Not Found, R304.2.2

Compliance	Description	Data	Compliance	Description	Data
N/A	Ramp Length (in)	64.0	No	Ramp Slope (%)	9.5
Yes	Ramp Width (in)	48.0	Yes	Ramp XSlope (%)	0.1
N/A	Flare Type LT	N/A	N/A	Flare Type RT	N/A
N/A	Flare Slope LT (%)	N/A	N/A	Flare Slope RT (%)	N/A
N/A	Flare Traversable LT?	N/A	N/A	Flare Traversable RT?	N/A
N/A	Landing Length (in)	N/A	N/A	DWS Provided?	N/A
N/A	Landing Width (in)	N/A	N/A	DWS Contrast?	N/A
N/A	Landing Slope (%)	N/A	N/A	DWS Length (in)	N/A
N/A	Landing X Slope (%)	N/A	N/A	DWS Full Width?	N/A
N/A	Landing Curb? (Y/N)	N/A	N/A	DWS Offset (in)	N/A
N/A	Shared Landing?	N/A			
N/A	Gutter Ponding?	N/A	N/A	Gutter Slope (%)	N/A
N/A	Gutter Lip Ht (in)	N/A	N/A	Gutter X Slope (%)	N/A
N/A	Painted X Walk1?	Yes	N/A	Painted X Walk2?	N/A
	X Walk 1 Direction	To NE		X Walk 2 Direction	N/A
N/A	X Walk 1 Width (in)	110.0	N/A	X Walk 2 Width (in)	N/A
	X Walk 1 Slope (%)	1.9		X Walk 2 Slope (%)	N/A
	X Walk 1 X Slope (%)	1.4		X Walk 2 X Slope (%)	N/A

Possible Solutions:

Remove & Replace Entire Ramp.

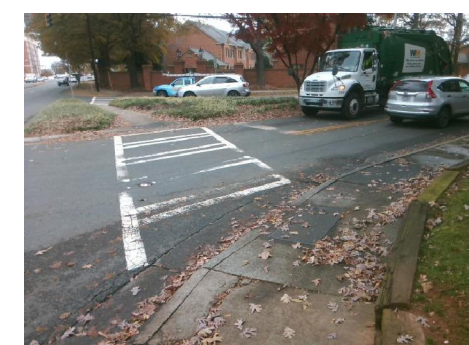
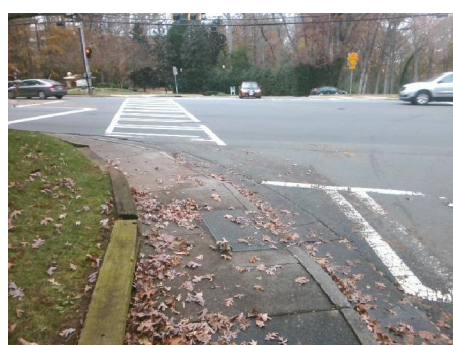
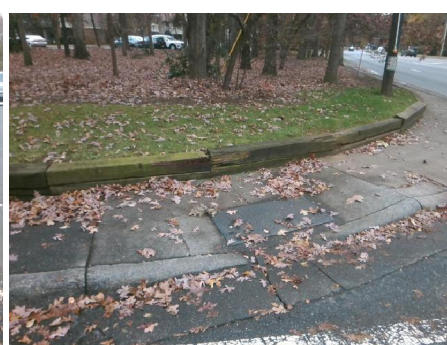
N/A	Ramp inside XWalk1?	Yes	N/A	Ramp inside XWalk2?	N/A
	Road Slope (%)	N/A	N/A	Clear Space?	N/A
	Road X Slope (%)	N/A	N/A	Clear Space to XWalk (in)	N/A
N/A	Any Obstructions?	N/A	N/A	Storm Grate/Utility Hazard?	N/A
	Obstruction Type			Storm Grate/Utility Type	
		N/A			N/A
			Yes	Surface Condition? (G/P)	Good
