Access Compliance Report

Public Rights-of-Way

(Curb Ramps)

Intersection ID: 28270	Main Street: PEMSWOOD_ST	Cross Street: SUMMER CLUB_RD	Location: S
ADA ID: 42B468099249	Ramp Type: PerpDiag	Initial Pass/Fail: Fail	Overall Compliance: No
		Severity Score: 12.5

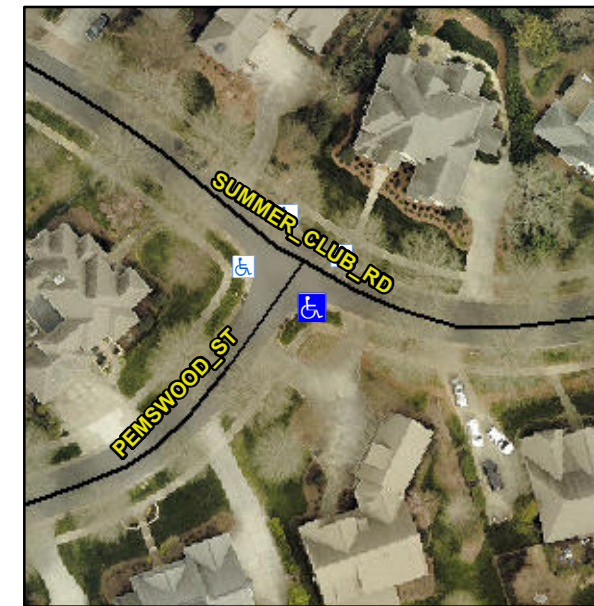
R304.2.2

Compliance	Description	Data	Compliance	Description	Data
N/A	Ramp Length (in)	102.0	No	Ramp Slope (%)	8.9
Yes	Ramp Width (in)	49.0	Yes	Ramp XSlope (%)	1.7
N/A	Flare Type LT	N/A	N/A	Flare Type RT	N/A
N/A	Flare Slope LT (%)	N/A	N/A	Flare Slope RT (%)	N/A
N/A	Flare Traversable LT?	N/A	N/A	Flare Traversable RT?	N/A
N/A	Landing Length (in)	N/A	N/A	DWS Provided?	N/A
N/A	Landing Width (in)	N/A	N/A	DWS Contrast?	N/A
N/A	Landing Slope (%)	N/A	N/A	DWS Length (in)	N/A
N/A	Landing X Slope (%)	N/A	N/A	DWS Full Width?	N/A
N/A	Landing Curb? (Y/N)	N/A	N/A	DWS Offset (in)	N/A
N/A	Shared Landing?	N/A			
N/A	Gutter Ponding?	N/A	N/A	Gutter Slope (%)	N/A
N/A	Gutter Lip Ht (in)	N/A	N/A	Gutter X Slope (%)	N/A
N/A	Painted X Walk1?	No	N/A	Painted X Walk2?	No
	X Walk 1 Direction	To NE		X Walk 2 Direction	To NW
N/A	X Walk 1 Width (in)	N/A	N/A	X Walk 2 Width (in)	N/A
	X Walk 1 Slope (%)	1.1		X Walk 2 Slope (%)	1.5
	X Walk 1 X Slope (%)	1.3		X Walk 2 X Slope (%)	0.6

N/A	Ramp inside XWalk1?	N/A	N/A	Ramp inside XWalk2?	N/A
	Road Slope (%)	0.8	N/A	Clear Space?	N/A
	Road X Slope (%)	1.5	N/A	Clear Space to XWalk (in)	N/A
N/A	Any Obstructions?	N/A	N/A	Storm Grate/Utility Hazard?	N/A
	Obstruction Type			Storm Grate/Utility Type	
		N/A			N/A
		Yes		Surface Condition? (G/P)	Good

Remove & Replace Curb Ramp With Two New Directional Ramps or Equivalent.

\$ 3200.00
