Access Compliance Report

Public Rights-of-Way

(Curb Ramps)

Intersection ID: 6987	Main Street: W_ROCKY_RIVER_RD	Cross Street: ROCKLAND_DR	Location: NE
ADA ID: 42B9818A5B01	Ramp Type: Perp	Initial Pass/Fail: Fail	Overall Compliance: No
Severity Score: 13.75			
Codes/Mitigation Info/Possible Solution		Field Measurements/Component Compliance

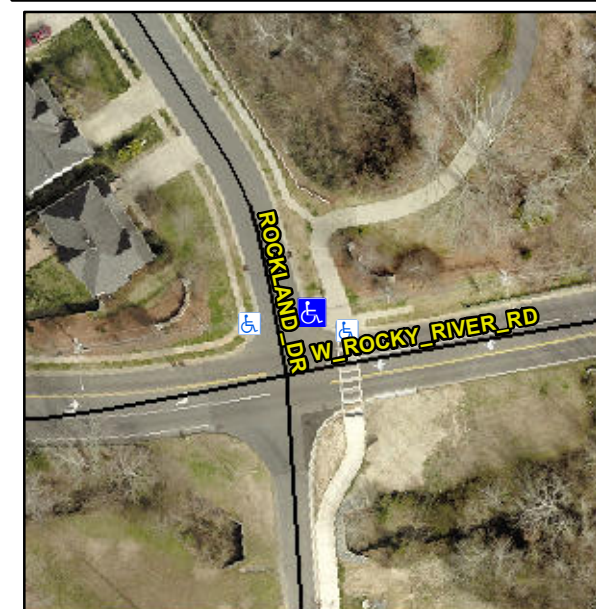
Not Found, R304.2.2, R304.5.3

Compliance	Description	Data	Compliance	Description	Data
N/A	Ramp Length (in)	98.0	No	Ramp Slope (%)	8.6
Yes	Ramp Width (in)	48.0	No	Ramp XSlope (%)	4.1
N/A	Flare Type LT	N/A	N/A	Flare Type RT	N/A
N/A	Flare Slope LT (%)	N/A	N/A	Flare Slope RT (%)	N/A
N/A	Flare Traversable LT?	N/A	N/A	Flare Traversable RT?	N/A
N/A	Landing Length (in)	N/A	N/A	DWS Provided?	N/A
N/A	Landing Width (in)	N/A	N/A	DWS Contrast?	N/A
N/A	Landing Slope (%)	N/A	N/A	DWS Length (in)	N/A
N/A	Landing X Slope (%)	N/A	N/A	DWS Full Width?	N/A
N/A	Landing Curb? (Y/N)	N/A	N/A	DWS Offset (in)	N/A
N/A	Shared Landing?	N/A			
N/A	Gutter Ponding?	N/A	N/A	Gutter Slope (%)	N/A
N/A	Gutter Lip Ht (in)	1.0	N/A	Gutter X Slope (%)	N/A
N/A	Painted X Walk1?	No	N/A	Painted X Walk2?	N/A
	X Walk 1 Direction	To W		X Walk 2 Direction	N/A
N/A	X Walk 1 Width (in)	N/A	N/A	X Walk 2 Width (in)	N/A
	X Walk 1 Slope (%)	3.5		X Walk 2 Slope (%)	N/A
	X Walk 1 X Slope (%)	3.5		X Walk 2 X Slope (%)	N/A

N/A	Ramp inside XWalk1?	N/A	N/A	Ramp inside XWalk2?	N/A
	Road Slope (%)	N/A	N/A	Clear Space?	N/A
	Road X Slope (%)	N/A	N/A	Clear Space to XWalk (in)	N/A
N/A	Any Obstructions?	N/A	N/A	Storm Grate/Utility Hazard?	N/A
	Obstruction Type			Storm Grate/Utility Type	
		N/A			N/A
		Yes		Surface Condition? (G/P)	Good

Possible Solutions:

Remove & Replace Entire Ramp.
