Access Compliance Report Public Rights-of-Way (Curb Ramps)

Intersection ID: 42744 Main Street: BUCHANNON_CORNER_DR					DANIEL_PLACE_DR	Location:	SW		
ADA ID: 42D3C0ACA	A81D Ramp Type: PerpDiag			itial Pass/Fail: Fail Overall Compliance: No				o Severity Score:	21.25
	Field Measurements/Component Compliance								
	Ere	Possible Solutions:		Compliance Description		Data Compliance Description			Data
The Manager of the second		Remove & Replace Curb Ramp With Two New Directional Ramps or Equivalent.	lith	N/A	Ramp Length (in)	47.0	Yes	Ramp Slope (%)	5.5
SHIT OF MEL			-	No	Ramp Width (in)	41.0	No	Ramp XSlope (%)	5.5
Augent I				N/A	Flare Type LT	N/A	N/A	Flare Type RT	N/A
				N/A	Flare Slope LT (%)	N/A	N/A	Flare Slope RT (%)	N/A
du er i	5.03			N/A	Flare Traversable LT?	N/A	N/A	Flare Traversable RT?	N/A
The ma	C. PLACE P			N/A	Landing Length (in)	N/A	N/A	DWS Provided?	N/A
DAULAR 6.		Surveyor Notes:		N/A	Landing Width (in)	N/A	N/A	DWS Contrast?	N/A

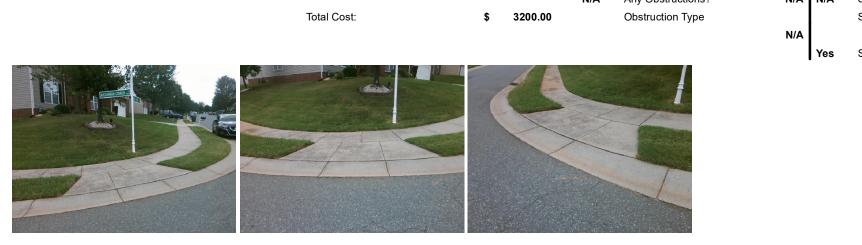
- t. B	N/A		N/A	Landing Slope (%)	N/A	N/A	DWS Length (in)	N/A
PROW/ADA: Not Found, R304.5.1, R304.5.3				N/A	Landing X Slope (%)	N/A	N/A	DWS Full Width?	N/A
				N/A	Landing Curb? (Y/N)	N/A	N/A	DWS Offset (in)	N/A
				N/A	Shared Landing?	N/A			
				N/A	Gutter Ponding?	N/A	N/A	Gutter Slope (%)	N/A
				N/A	Gutter Lip Ht (in)	N/A	N/A	Gutter X Slope (%)	N/A
				N/A	Painted X Walk1?	No	N/A	Painted X Walk2?	No
					X Walk 1 Direction	To E		X Walk 2 Direction	To N
Standard & William				N/A	X Walk 1 Width (in)	N/A	N/A	X Walk 2 Width (in)	N/A
Street 1 Name	BUCHANNON CORNER DR				X Walk 1 Slope (%)	3.4		X Walk 2 Slope (%)	2.6
Stop Condition-Street 2	StopSign				X Walk 1 X Slope (%)	2.0		X Walk 2 X Slope (%)	3.3
Street 2 Name	DANIEL PLACE DR			N/A	Ramp inside XWalk1?	N/A	N/A	Ramp inside XWalk2?	N/A
Stop Condition-Street 1	None				Road Slope (%)	3.9	N/A	Clear Space?	N/A
					Road X Slope (%)	1.8	N/A	Clear Space to XWalk (in)	N/A
