# Access Compliance Report

## Public Rights-of-Way

### (Curb Ramps)

| Intersection ID: 23427 | Main Street: GRUENEWALD_LN | Cross Street: OBERBECK_LN | Location: SE |

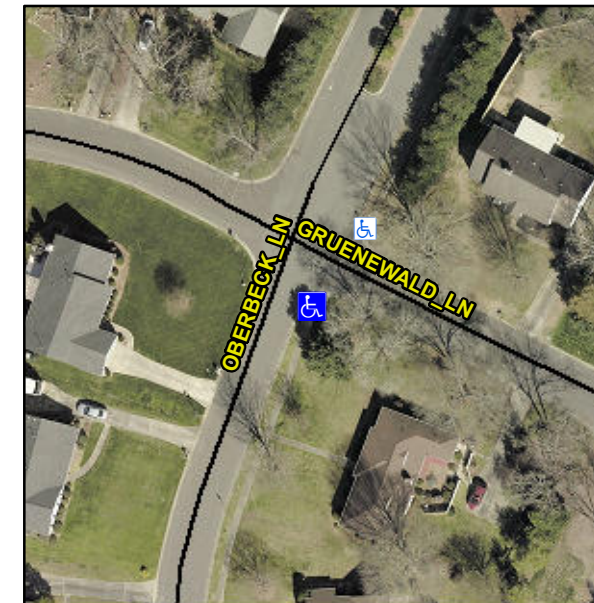
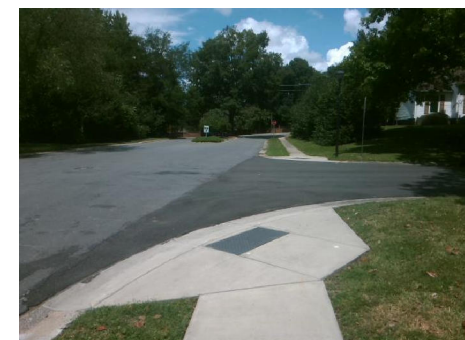
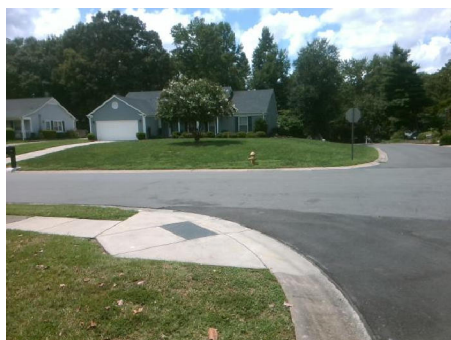
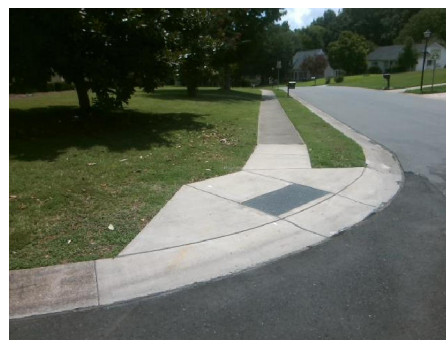
| ADA ID: 42E0E3DD2B8F | Ramp Type: BlendTrans2 | Initial Pass/Fail: Fail | Overall Compliance: No |

**Not Found, R304.5.1**

| Compliance | Description | Data | Compliance | Description | Data |
|---|---|---|---|---|---|
| No | Ramp Width (in) | 47.0 | Yes | BlendTrans XSlope (%) | 1.2 |
| | | | No | Curb Slope (%) | 15.3 |

**Remove & Replace Curb Ramp With Two New Directional Ramps or Equivalent.**
