# Access Compliance Report

## Public Rights-of-Way

### (Curb Ramps)

Intersection ID: 45785	Main Street: SUGARBUSH_DR	Cross Street: LONG_HILL_DR	Location:	N
ADA ID: 42E209E90B6F	Ramp Type: BlendTrans1	Initial Pass/Fail: Pass	Overall Compliance: No	Severity Score: 2.5
Codes/Mitigation Info/Possible Solution		Field Measurements/Component Compliance

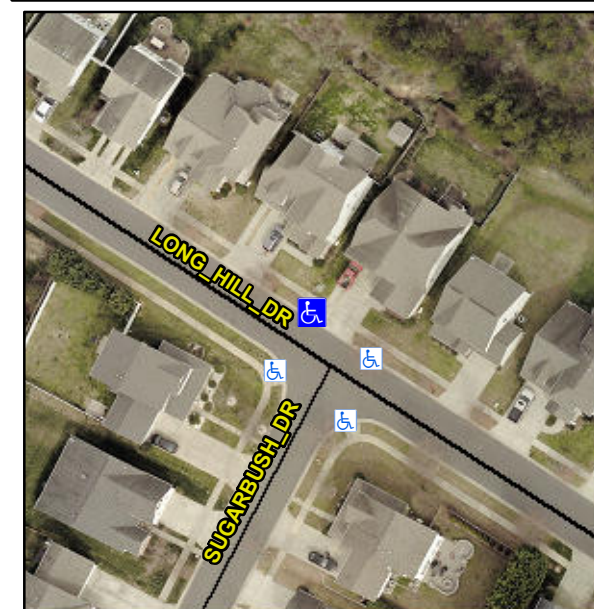
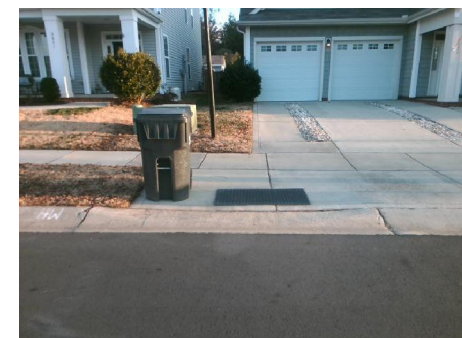
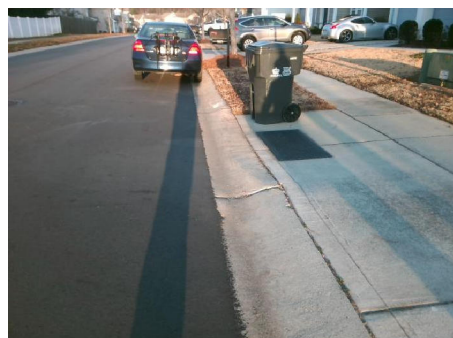
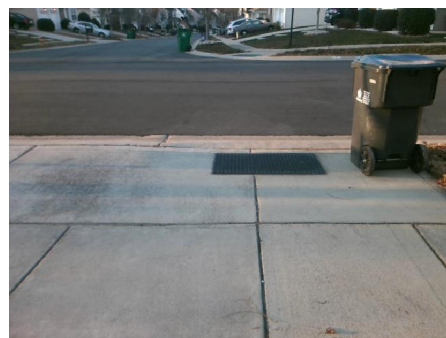
**Not Found, R304.2.2-Perp, R304.3.2-Para, R305.1.4, R305.2**

Compliance	Description	Data	Compliance	Description	Data
N/A	Ramp Length (in)	71.0	Yes	BlendTrans Slope (%)	5.0
Yes	Ramp Width (in)	48.0	Yes	BlendTrans XSlope (%)	0.2
N/A	Flare Type LT	Sloped	N/A	Flare Type RT	Sloped
Yes	Flare Slope LT (%)	2.4	Yes	Flare Slope RT (%)	6.1
N/A	Flare Traversable LT?	Yes	N/A	Flare Traversable RT?	Yes
Yes	Landing Length (in)	48.0	Yes	DWS Provided?	Yes
Yes	Landing Width (in)	48.0	Yes	DWS Contrast?	Yes
No	Landing Slope (%)	2.9	Yes	DWS Length (in)	25.5
Yes	Landing X Slope (%)	1.9	No	DWS Full Width?	No
N/A	Landing Curb? (Y/N)	No	No	DWS Offset (in)	7.0
N/A	Shared Landing?	No			
Yes	Gutter Ponding?	No	Yes	Gutter Slope (%)	1.8
Yes	Gutter Lip Ht (in)	0.0	Yes	Gutter X Slope (%)	0.9
N/A	Painted X Walk1?	No	N/A	Painted X Walk2?	N/A
	X Walk 1 Direction	To SW		X Walk 2 Direction	N/A
	X Walk 1 Width (in)	N/A		X Walk 2 Width (in)	N/A
	X Walk 1 Slope (%)	1.4		X Walk 2 Slope (%)	N/A
	X Walk 1 X Slope (%)	1.3		X Walk 2 X Slope (%)	N/A

N/A	Ramp inside XWalk1?	N/A	N/A	Ramp inside XWalk2?	N/A
	Road Slope (%)	1.3		Clear Space?	Yes
	Road X Slope (%)	1.4	N/A	Clear Space to XWalk (in)	N/A
Yes	Any Obstructions?	No	Yes	Storm Grate/Utility Hazard?	No
	Obstruction Type			Storm Grate/Utility Type	
		N/A			N/A
			Yes	Surface Condition? (G/P)	Good
			No	Curb Slope (%)	17.6

Possible Solutions:

**Remove & Replace Curb Ramp With Two New Directional Ramps or Equivalent.**
