Access Compliance Report

Public Rights-of-Way

(Curb Ramps)

Intersection ID: 20660	Main Street: SANDY_PORTER_RD	Cross Street: STEELECHASE_DR	Location: NW
ADA ID: 42E48BB5833B	Ramp Type: Perp	Initial Pass/Fail: Fail	Overall Compliance: No
Severity Score: 13.75			
Codes/Mitigation Info/Possible Solution		Field Measurements/Component Compliance

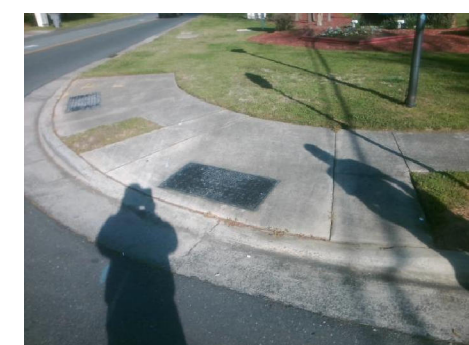
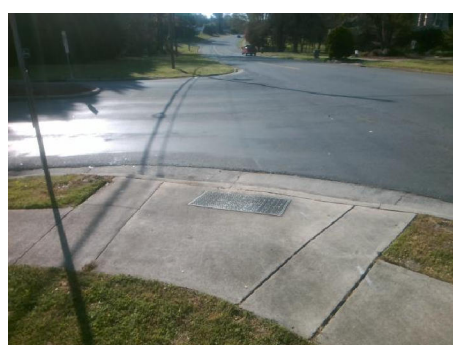
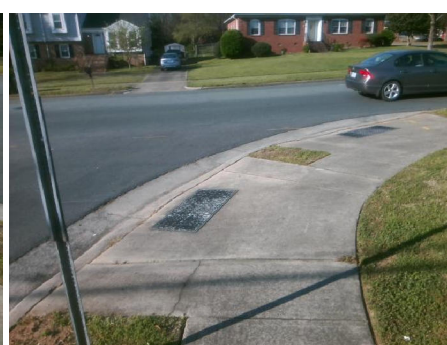
Not Found, R304.2.2, R304.5.3

Compliance	Description	Data	Compliance	Description	Data
N/A	Ramp Length (in)	94.0	No	Ramp Slope (%)	9.2
Yes	Ramp Width (in)	48.0	No	Ramp XSlope (%)	4.0
N/A	Flare Type LT	N/A	N/A	Flare Type RT	N/A
N/A	Flare Slope LT (%)	N/A	N/A	Flare Slope RT (%)	N/A
N/A	Flare Traversable LT?	N/A	N/A	Flare Traversable RT?	N/A
N/A	Landing Length (in)	N/A	N/A	DWS Provided?	N/A
N/A	Landing Width (in)	N/A	N/A	DWS Contrast?	N/A
N/A	Landing Slope (%)	N/A	N/A	DWS Length (in)	N/A
N/A	Landing X Slope (%)	N/A	N/A	DWS Full Width?	N/A
N/A	Landing Curb? (Y/N)	N/A	N/A	DWS Offset (in)	N/A
N/A	Shared Landing?	N/A			
N/A	Gutter Ponding?	N/A	N/A	Gutter Slope (%)	N/A
N/A	Gutter Lip Ht (in)	N/A	N/A	Gutter X Slope (%)	N/A
N/A	Painted X Walk1?	No	N/A	Painted X Walk2?	N/A
	X Walk 1 Direction	To SE		X Walk 2 Direction	N/A
N/A	X Walk 1 Width (in)	N/A	N/A	X Walk 2 Width (in)	N/A
	X Walk 1 Slope (%)	1.7		X Walk 2 Slope (%)	N/A
	X Walk 1 X Slope (%)	3.7		X Walk 2 X Slope (%)	N/A

N/A	Ramp inside XWalk1?	N/A	N/A	Ramp inside XWalk2?	N/A
	Road Slope (%)	N/A	N/A	Clear Space?	N/A
	Road X Slope (%)	N/A	N/A	Clear Space to XWalk (in)	N/A
N/A	Any Obstructions?	N/A	N/A	Storm Grate/Utility Hazard?	N/A
	Obstruction Type			Storm Grate/Utility Type	
		N/A			N/A
			Yes	Surface Condition? (G/P)	Good

Remove & Replace Entire Ramp.
