# Access Compliance Report

## Public Rights-of-Way

### (Curb Ramps)

| Intersection ID: 29355 | Main Street: TETON_TL | Cross Street: ONEIDA_RD | Location: W |

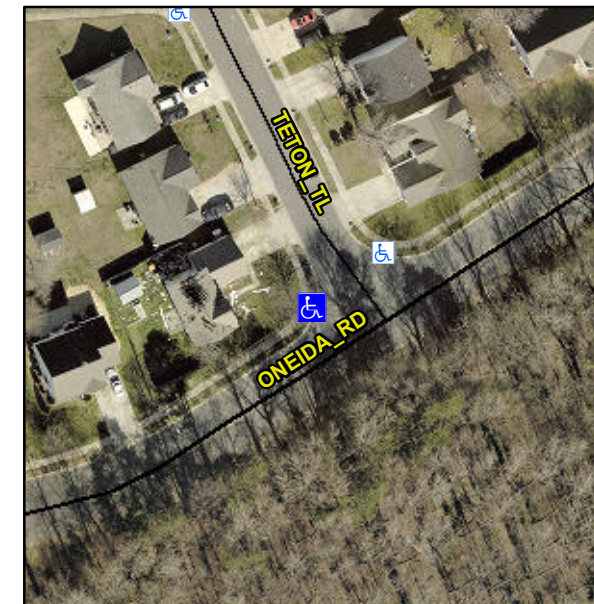
**RP < 5%, CURB LIP 0.75"**

**Not Found, R304.2.1, R304.2.2-Perp, R304.3.2-Para, R304.5.3, R305.1.4, R305.2, R302.7.2, R304.5.4**

**Remove & Replace Curb Ramp With Two New Directional Ramps or Equivalent. Remove & Replace Gutter.**

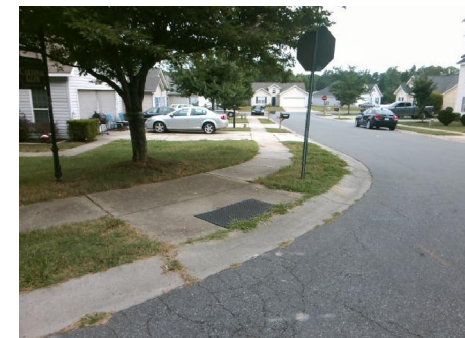
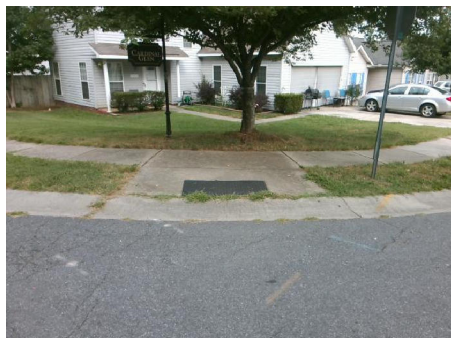
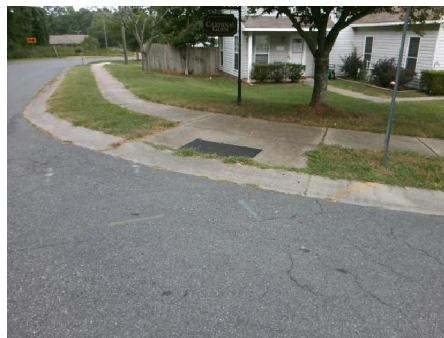
| Compliance | Description | Data | Compliance | Description | Data |
|---|---|---|---|---|---|
| No | Landing Length (in) | 46.5 | Yes | DWS Provided? | Yes |
| No | Landing Slope (%) | 3.2 | Yes | DWS Length (in) | 25.5 |
| No | Landing X Slope (%) | 4.3 | No | DWS Full Width? | No |
| Yes | Gutter Ponding? | No | No | Gutter Slope (%) | 5.7 |
| No | Gutter Lip Ht (in) | 0.3 | Yes | Gutter X Slope (%) | 0.4 |
