Access Compliance Report

Public Rights-of-Way

(Curb Ramps)

Intersection ID: 8311	Main Street: BUTLER_RD	Cross Street: INTERURBAN_AV	Location: NE
ADA ID: 42EFD773D8D	Ramp Type: Perp	Initial Pass/Fail: Fail	Overall Compliance: No
Severity Score: 8.75			
Codes/Mitigation Info/Possible Solution		Field Measurements/Component Compliance

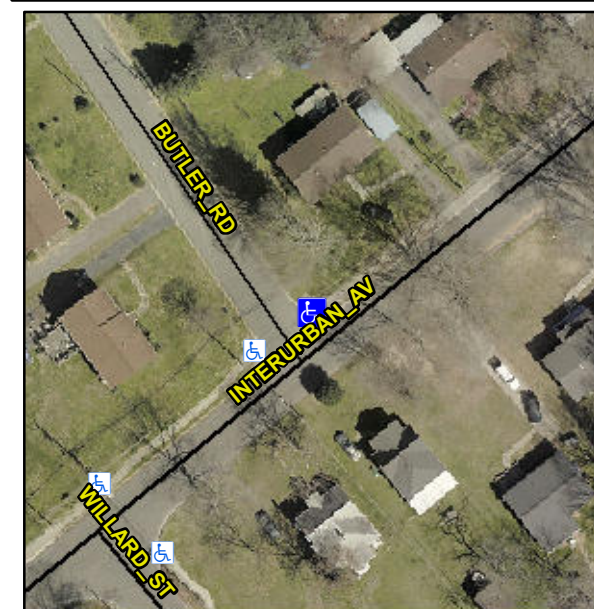
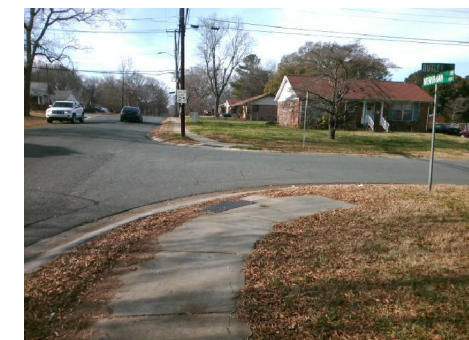
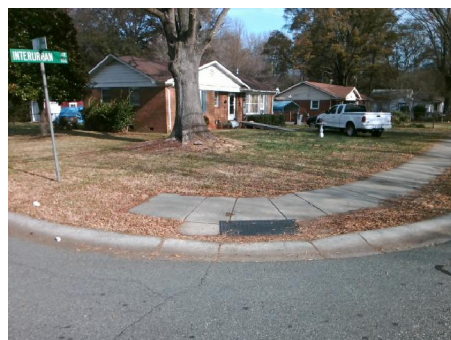
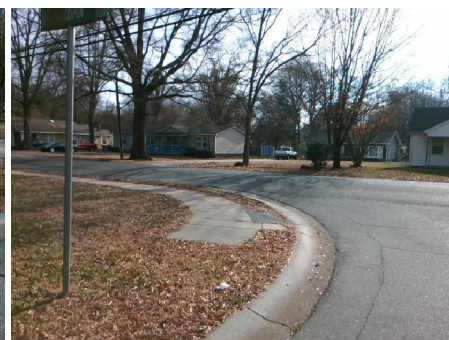
Not Found, R304.5.1

Compliance	Description	Data	Compliance	Description	Data
N/A	Ramp Length (in)	24.0	Yes	Ramp Slope (%)	5.4
No	Ramp Width (in)	36.0	Yes	Ramp XSlope (%)	0.2
N/A	Flare Type LT	N/A	N/A	Flare Type RT	N/A
N/A	Flare Slope LT (%)	N/A	N/A	Flare Slope RT (%)	N/A
N/A	Flare Traversable LT?	N/A	N/A	Flare Traversable RT?	N/A
N/A	Landing Length (in)	N/A	N/A	DWS Provided?	N/A
N/A	Landing Width (in)	N/A	N/A	DWS Contrast?	N/A
N/A	Landing Slope (%)	N/A	N/A	DWS Length (in)	N/A
N/A	Landing X Slope (%)	N/A	N/A	DWS Full Width?	N/A
N/A	Landing Curb? (Y/N)	N/A	N/A	DWS Offset (in)	N/A
N/A	Shared Landing?	N/A			
N/A	Gutter Ponding?	N/A	N/A	Gutter Slope (%)	N/A
N/A	Gutter Lip Ht (in)	N/A	N/A	Gutter X Slope (%)	N/A
N/A	Painted X Walk1?	No	N/A	Painted X Walk2?	N/A
	X Walk 1 Direction	To SW		X Walk 2 Direction	N/A
N/A	X Walk 1 Width (in)	N/A	N/A	X Walk 2 Width (in)	N/A
	X Walk 1 Slope (%)	2.8		X Walk 2 Slope (%)	N/A
	X Walk 1 X Slope (%)	4.1		X Walk 2 X Slope (%)	N/A

N/A	Ramp inside XWalk1?	N/A	N/A	Ramp inside XWalk2?	N/A
	Road Slope (%)	N/A	N/A	Clear Space?	N/A
	Road X Slope (%)	N/A	N/A	Clear Space to XWalk (in)	N/A
N/A	Any Obstructions?	N/A	N/A	Storm Grate/Utility Hazard?	N/A
	Obstruction Type			Storm Grate/Utility Type	
		N/A			N/A
			Yes	Surface Condition? (G/P)	Good

Remove & Replace Entire Ramp.
