# Access Compliance Report

## Public Rights-of-Way

### (Curb Ramps)

Intersection ID: 13980	Main Street: AUTUMN_END_CR	Cross Street: BARCLIFF_DR	Location:	S
ADA ID: 42F4721C378F	Ramp Type: Perp	Initial Pass/Fail: Fail	Overall Compliance: No	Severity Score: 25

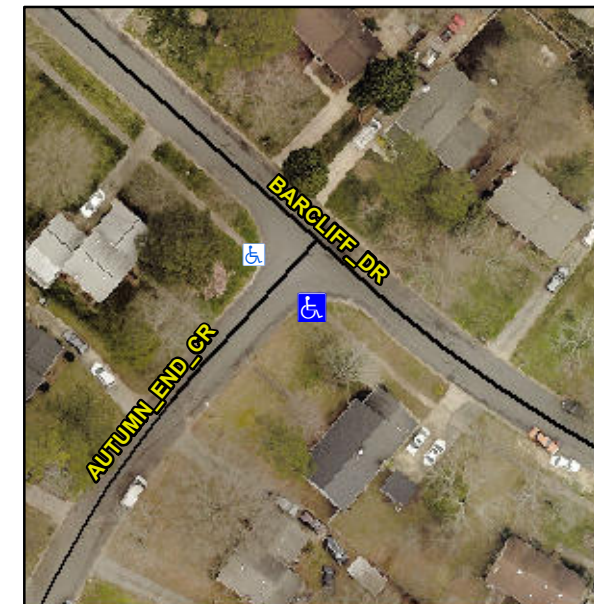
**Not Found, R304.2.2**

Compliance	Description	Data	Compliance	Description	Data
N/A	Ramp Length (in)	25.5	No	Ramp Slope (%)	12.1
Yes	Ramp Width (in)	48.0	Yes	Ramp XSlope (%)	0.9
N/A	Flare Type LT	N/A	N/A	Flare Type RT	N/A
N/A	Flare Slope LT (%)	N/A	N/A	Flare Slope RT (%)	N/A
N/A	Flare Traversable LT?	N/A	N/A	Flare Traversable RT?	N/A
N/A	Landing Length (in)	N/A	N/A	DWS Provided?	N/A
N/A	Landing Width (in)	N/A	N/A	DWS Contrast?	N/A
N/A	Landing Slope (%)	N/A	N/A	DWS Length (in)	N/A
N/A	Landing X Slope (%)	N/A	N/A	DWS Full Width?	N/A
N/A	Landing Curb? (Y/N)	N/A	N/A	DWS Offset (in)	N/A
N/A	Shared Landing?	N/A			
N/A	Gutter Ponding?	N/A	N/A	Gutter Slope (%)	N/A
N/A	Gutter Lip Ht (in)	N/A	N/A	Gutter X Slope (%)	N/A
N/A	Painted X Walk1?	No	N/A	Painted X Walk2?	N/A
	X Walk 1 Direction	To NW		X Walk 2 Direction	N/A
N/A	X Walk 1 Width (in)	N/A	N/A	X Walk 2 Width (in)	N/A
	X Walk 1 Slope (%)	2.8		X Walk 2 Slope (%)	N/A
	X Walk 1 X Slope (%)	5.8		X Walk 2 X Slope (%)	N/A

N/A	Ramp inside XWalk1?	N/A	N/A	Ramp inside XWalk2?	N/A
	Road Slope (%)	N/A	N/A	Clear Space?	N/A
	Road X Slope (%)	N/A	N/A	Clear Space to XWalk (in)	N/A
N/A	Any Obstructions?	N/A	N/A	Storm Grate/Utility Hazard?	N/A
	Obstruction Type			Storm Grate/Utility Type	
		N/A			N/A
			Yes	Surface Condition? (G/P)	Good

Possible Solutions:

**Remove & Replace Entire Ramp.**
