Access Compliance Report Public Rights-of-Way (Curb Ramps)

Intersection ID: 19257 Main Street: BEAM RD Cross Street: S_TRYON_ST Location: SW ADA ID: 42FE3D88D79D Ramp Type: PerpDiag Initial Pass/Fail: Fail **Overall Compliance: No** Severity Score: 21.25

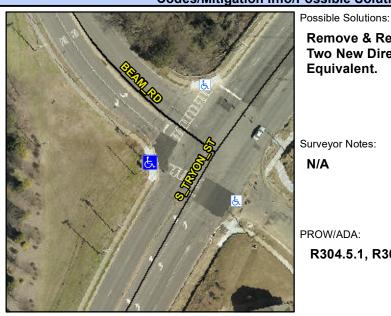
Compli	ance Description	Data	Compliance Description		Data
N/A	Ramp Length (in)	89.0	No	Ramp Slope (%)	8.4
No	Ramp Width (in)	45.0	Yes	Ramp XSlope (%)	0.9
N/A	Flare Type LT	N/A	N/A	Flare Type RT	N/A
N/A	Flare Slope LT (%)	N/A	N/A	Flare Slope RT (%)	N/A
N/A	Flare Traversable LT?	N/A	N/A	Flare Traversable RT?	N/A
N/A	Landing Length (in)	N/A	N/A	DWS Provided?	N/A
N/A	Landing Width (in)	N/A	N/A	DWS Contrast?	N/A
N/A	Landing Slope (%)	N/A	N/A	DWS Length (in)	N/A
N/A	Landing X Slope (%)	N/A	N/A	DWS Full Width?	N/A
N/A	Landing Curb? (Y/N)	N/A	N/A	DWS Offset (in)	N/A
N/A	Shared Landing?	N/A			
N/A	Gutter Ponding?	N/A	N/A	Gutter Slope (%)	N/A
N/A	Gutter Lip Ht (in)	N/A	N/A	Gutter X Slope (%)	N/A
N/A	Painted X Walk1?	Yes	N/A	Painted X Walk2?	Yes
	X Walk 1 Direction	To SE		X Walk 2 Direction	To NE
N/A	X Walk 1 Width (in)	110.0	N/A	X Walk 2 Width (in)	113.0
	X Walk 1 Slope (%)	1.5		X Walk 2 Slope (%)	3.6
	X Walk 1 X Slope (%)	3.7		X Walk 2 X Slope (%)	0.2

N/A	Ramp inside XWalk1?	Yes	N/A	Ramp inside XWalk2?	Yes
	Road Slope (%)	1.9	N/A	Clear Space?	N/A
	Road X Slope (%)	4.0	N/A	Clear Space to XWalk (in)	N/A
N/A	Any Obstructions?	N/A	N/A	Storm Grate/Utility Hazard?	N/A
	Obstruction Type			Storm Grate/Utility Type	
		N/A			N/A
			l	0 (0) 0 (5 :=)

Remove & Replace Curb Ramp With **Two New Directional Ramps or** Equivalent.
