## Access Compliance Report Public Rights-of-Way (Curb Ramps)

Intersection ID: 7637 Main Street: HARVEY\_ST Cross Street: JOE\_ST Location: N

ADA ID: 42FE9A4622AE Ramp Type: Perp Initial Pass/Fail: Fail Overall Compliance: No Severity Score: 21.25

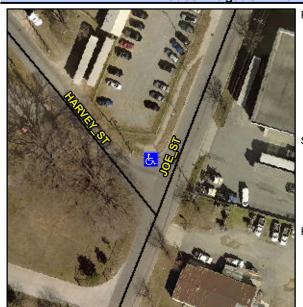
Comp	oliance Description	Data	Comp	liance Description	Data
N/A	Ramp Length (in)	94.5	Yes	Ramp Slope (%)	7.5
No	Ramp Width (in)	44.5	No	Ramp XSlope (%)	6.8
N/A	Flare Type LT	N/A	N/A	Flare Type RT	N/A
N/A	Flare Slope LT (%)	N/A	N/A	Flare Slope RT (%)	N/A
N/A	Flare Traversable LT?	N/A	N/A	Flare Traversable RT?	N/A
N/A	Landing Length (in)	N/A	N/A	DWS Provided?	N/A
N/A	Landing Width (in)	N/A	N/A	DWS Contrast?	N/A
N/A	Landing Slope (%)	N/A	N/A	DWS Length (in)	N/A
N/A	Landing X Slope (%)	N/A	N/A	DWS Full Width?	N/A
N/A	Landing Curb? (Y/N)	N/A	N/A	DWS Offset (in)	N/A
N/A	Shared Landing?	N/A			
N/A	Gutter Ponding?	N/A	N/A	Gutter Slope (%)	N/A
N/A	Gutter Lip Ht (in)	N/A	N/A	Gutter X Slope (%)	N/A
N/A	Painted X Walk1?	No	N/A	Painted X Walk2?	N/A
	X Walk 1 Direction	To S		X Walk 2 Direction	N/A
N/A	X Walk 1 Width (in)	N/A	N/A	X Walk 2 Width (in)	N/A
	X Walk 1 Slope (%)	4.5		X Walk 2 Slope (%)	N/A
	X Walk 1 X Slope (%)	6.7		X Walk 2 X Slope (%)	N/A

N/A	Ramp inside XWalk1?	N/A	N/A	Ramp inside XWalk2?	N/A
	Road Slope (%)	N/A	N/A	Clear Space?	N/A
	Road X Slope (%)	N/A	N/A	Clear Space to XWalk (in)	N/A
N/A	Any Obstructions?	N/A	N/A	Storm Grate/Utility Hazard?	N/A
	Obstruction Type		l	Storm Grate/Utility Type	
		N/A			N/A
			Yes	Surface Condition? (G/P)	Good
THE STATE OF THE S

Possible Solutions:						
Remove & Replace Entire Ramp.						
Surveyor Notes:						
·						
N/A						
PROW/ADA:						
Not Found, R304.5.1, R304.5.3						
,
