# Access Compliance Report

## Public Rights-of-Way

### (Curb Ramps)

Intersection ID: N/A	Main Street: BROOKSVALE_ST	Cross Street: NOBLES_AV	Location: NW
ADA ID: 42FFC6D11C43	Ramp Type: Perp	Initial Pass/Fail: Fail	Overall Compliance: No
		Severity Score: 12.5

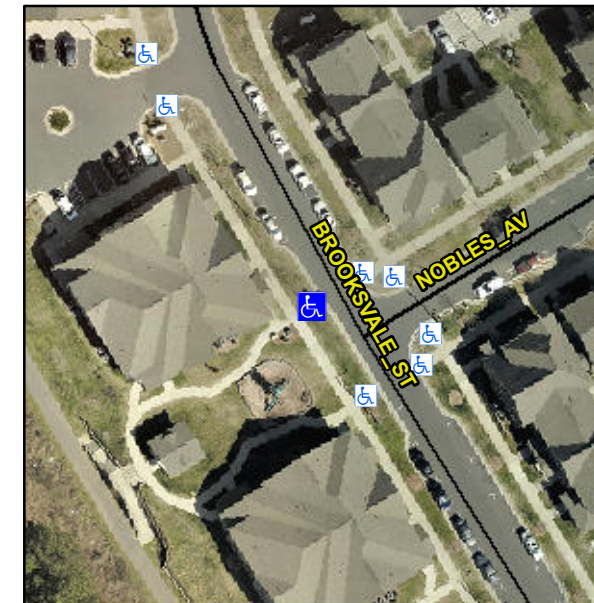
**Not Found, R304.2.2**

Compliance	Description	Data	Compliance	Description	Data
N/A	Ramp Length (in)	72.0	No	Ramp Slope (%)	8.6
Yes	Ramp Width (in)	71.0	Yes	Ramp XSlope (%)	1.9
N/A	Flare Type LT	N/A	N/A	Flare Type RT	N/A
N/A	Flare Slope LT (%)	N/A	N/A	Flare Slope RT (%)	N/A
N/A	Flare Traversable LT?	N/A	N/A	Flare Traversable RT?	N/A
N/A	Landing Length (in)	N/A	N/A	DWS Provided?	N/A
N/A	Landing Width (in)	N/A	N/A	DWS Contrast?	N/A
N/A	Landing Slope (%)	N/A	N/A	DWS Length (in)	N/A
N/A	Landing X Slope (%)	N/A	N/A	DWS Full Width?	N/A
N/A	Landing Curb? (Y/N)	N/A	N/A	DWS Offset (in)	N/A
N/A	Shared Landing?	N/A			
N/A	Gutter Ponding?	N/A	N/A	Gutter Slope (%)	N/A
N/A	Gutter Lip Ht (in)	N/A	N/A	Gutter X Slope (%)	N/A
N/A	Painted X Walk1?	No	N/A	Painted X Walk2?	N/A
	X Walk 1 Direction	To NE		X Walk 2 Direction	N/A
N/A	X Walk 1 Width (in)	N/A	N/A	X Walk 2 Width (in)	N/A
	X Walk 1 Slope (%)	4.0		X Walk 2 Slope (%)	N/A
	X Walk 1 X Slope (%)	1.6		X Walk 2 X Slope (%)	N/A

N/A	Ramp inside XWalk1?	N/A	N/A	Ramp inside XWalk2?	N/A
	Road Slope (%)	N/A	N/A	Clear Space?	N/A
	Road X Slope (%)	N/A	N/A	Clear Space to XWalk (in)	N/A
N/A	Any Obstructions?	N/A	N/A	Storm Grate/Utility Hazard?	N/A
	Obstruction Type			Storm Grate/Utility Type	
		N/A			N/A
			Yes	Surface Condition? (G/P)	Good

**Remove & Replace Entire Ramp.**
