# Access Compliance Report

## Public Rights-of-Way

### (Curb Ramps)

Intersection ID: 31257	Main Street: EWEN_CR	Cross Street: SACKETT_WY	Location: NE
ADA ID: 4301821050DE	Ramp Type: PerpDiag	Initial Pass/Fail: Fail	Overall Compliance: No
		Severity Score: 18.75

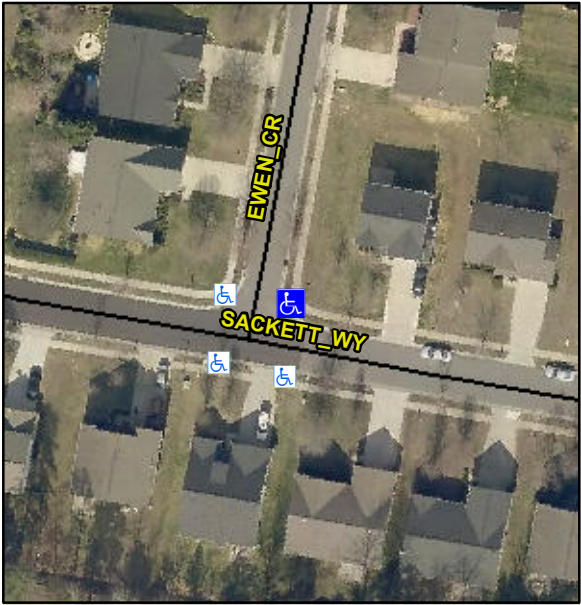
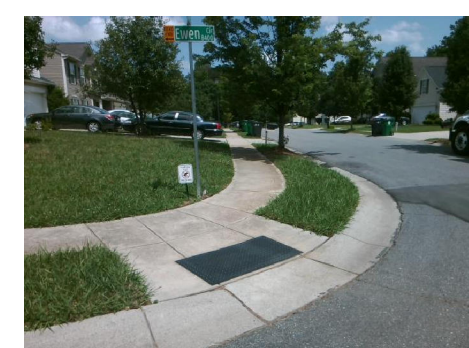
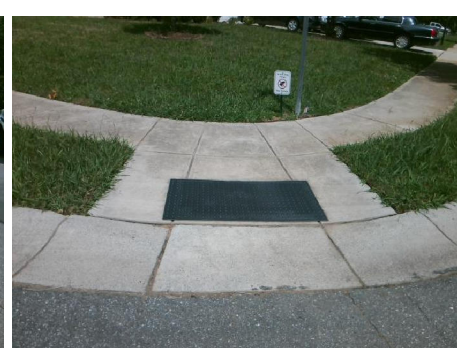
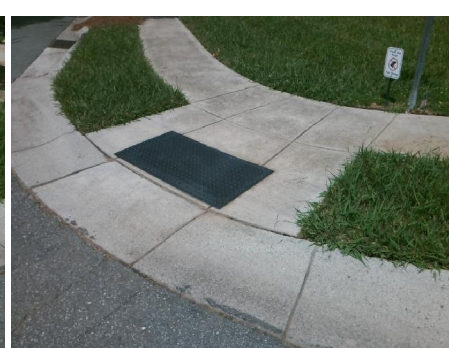
Possible Solutions:		<b>Compliance</b>	<b>Description</b>	<b>Data</b>
	<b>Remove &amp; Replace Curb Ramp With Two New Directional Ramps or Equivalent.</b>		<b>Yes</b>	Ramp Length (in)	6.8
			<b>No</b>	Ramp Width (in)	2.1
			<b>N/A</b>	Flare Type LT	N/A
			<b>N/A</b>	Flare Slope LT (%)	N/A
			<b>N/A</b>	Flare Traversable LT?	N/A
			<b>N/A</b>	Landing Length (in)	N/A
			<b>N/A</b>	Landing Width (in)	N/A
			<b>N/A</b>	Landing Slope (%)	N/A
			<b>N/A</b>	Landing X Slope (%)	N/A
<p>Surveyor Notes:</p> <p><b>N/A</b></p> <p>PROW/ADA:</p> <p><b>R304.5.1, R304.5.3</b></p>			<b>N/A</b>	Flare Type RT	N/A
			<b>N/A</b>	Flare Slope RT (%)	N/A
			<b>N/A</b>	Flare Traversable RT?	N/A
			<b>N/A</b>	DWS Provided?	N/A
			<b>N/A</b>	DWS Contrast?	N/A
			<b>N/A</b>	DWS Length (in)	N/A
			<b>N/A</b>	DWS Full Width?	N/A
			<b>N/A</b>	DWS Offset (in)	N/A

<b>N/A</b>	Shared Landing?	N/A
			<b>N/A</b>	Gutter Ponding?	N/A
			<b>N/A</b>	Gutter Lip Ht (in)	N/A
			<b>No</b>	Painted X Walk1?	No
				X Walk 1 Direction	To W
			<b>N/A</b>	X Walk 1 Width (in)	N/A
			<b>0.9</b>	X Walk 1 Slope (%)	N/A
			<b>0.9</b>	X Walk 1 X Slope (%)	N/A
			<b>N/A</b>	Ramp inside XWalk1?	N/A
			<b>N/A</b>	Road Slope (%)	N/A
			<b>N/A</b>	Road X Slope (%)	N/A
			<b>N/A</b>	Any Obstructions?	N/A
				Obstruction Type	
			<b>N/A</b>		N/A
			<b>Yes</b>	Surface Condition? (G/P)	Good

Total Cost: \$ 3200.00
