Access Compliance Report

Public Rights-of-Way

(Curb Ramps)

| Intersection ID: 50618 | Main Street: YELLOW_OAK_RD | Cross Street: ABNEY_CT | Location: | N |

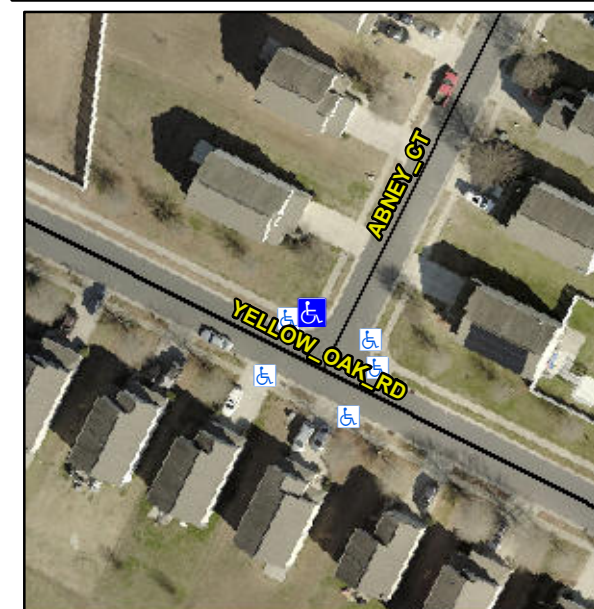
| ADA ID: 4307B0228C28 | Ramp Type: Perp | Initial Pass/Fail: Pass | Overall Compliance: No | Severity Score: 0 |

Not Found, R304.5.3, R305.2

| Compliance | Description | Data | Compliance | Description | Data |
|---|---|---|---|---|---|
| No | Landing X Slope (%) | 2.9 | Yes | DWS Full Width? | Yes |
| N/A | Landing Curb? (Y/N) | No | No | DWS Offset (in) | 6.5 |

Possible Solutions:

Remove & Replace Entire Ramp.
