Access Compliance Report

Public Rights-of-Way

(Curb Ramps)

Intersection ID: 43653	Main Street: HUNTINGTON_MEADOW_LN	Cross Street: TAGGERT_TRAIL_DR	Location: S
ADA ID: 430E36829AE2	Ramp Type: Perp	Initial Pass/Fail: Fail	Overall Compliance: No
Severity Score: 30			
Codes/Mitigation Info/Possible Solution		Field Measurements/Component Compliance

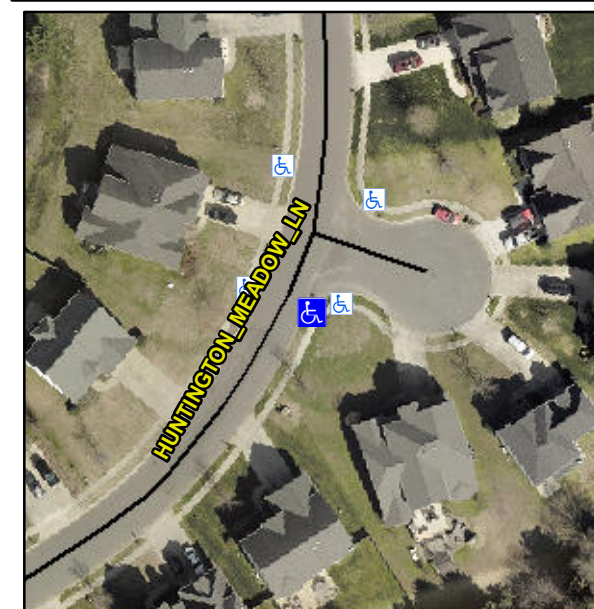
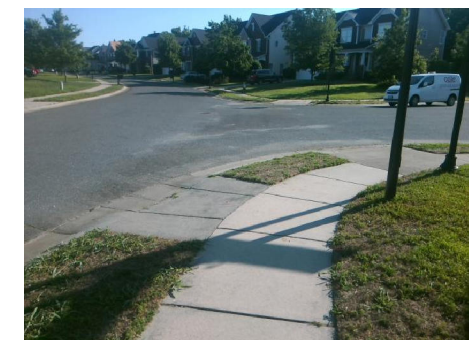
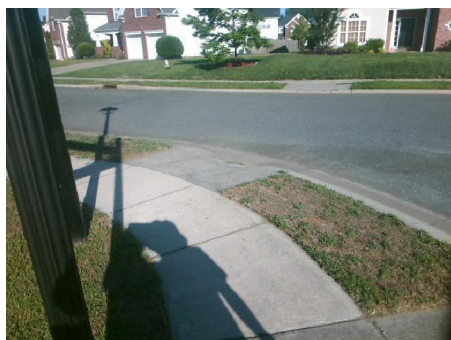
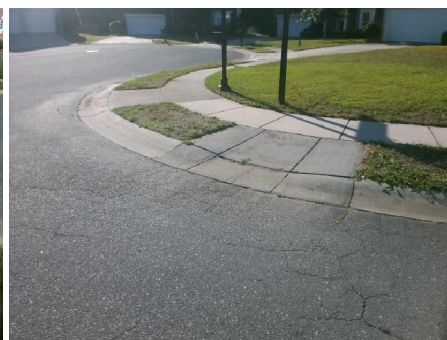
Compliance	Description	Data	Compliance	Description	Data
N/A	Ramp Length (in)	47.0	No	Ramp Slope (%)	9.2
No	Ramp Width (in)	34.5	Yes	Ramp XSlope (%)	1.5
N/A	Flare Type LT	N/A	N/A	Flare Type RT	N/A
N/A	Flare Slope LT (%)	N/A	N/A	Flare Slope RT (%)	N/A
N/A	Flare Traversable LT?	N/A	N/A	Flare Traversable RT?	N/A
N/A	Landing Length (in)	N/A	N/A	DWS Provided?	N/A
N/A	Landing Width (in)	N/A	N/A	DWS Contrast?	N/A
N/A	Landing Slope (%)	N/A	N/A	DWS Length (in)	N/A
N/A	Landing X Slope (%)	N/A	N/A	DWS Full Width?	N/A
N/A	Landing Curb? (Y/N)	N/A	N/A	DWS Offset (in)	N/A
N/A	Shared Landing?	N/A			
N/A	Gutter Ponding?	N/A	N/A	Gutter Slope (%)	N/A
N/A	Gutter Lip Ht (in)	N/A	N/A	Gutter X Slope (%)	N/A
N/A	Painted X Walk1?	No	N/A	Painted X Walk2?	N/A
	X Walk 1 Direction	To NW		X Walk 2 Direction	N/A
N/A	X Walk 1 Width (in)	N/A	N/A	X Walk 2 Width (in)	N/A
	X Walk 1 Slope (%)	0.8		X Walk 2 Slope (%)	N/A
	X Walk 1 X Slope (%)	1.0		X Walk 2 X Slope (%)	N/A

N/A	Ramp inside XWalk1?	N/A	N/A	Ramp inside XWalk2?	N/A
	Road Slope (%)	N/A	N/A	Clear Space?	N/A
	Road X Slope (%)	N/A	N/A	Clear Space to XWalk (in)	N/A
N/A	Any Obstructions?	N/A	N/A	Storm Grate/Utility Hazard?	N/A
	Obstruction Type			Storm Grate/Utility Type	
		N/A			N/A
			Yes	Surface Condition? (G/P)	Good

Possible Solutions:

Remove & Replace Entire Ramp.

R304.5.1, R304.2.2
