Access Compliance Report

Public Rights-of-Way

(Curb Ramps)

Intersection ID: 43145	Main Street: E_INDEPENDENCE_BV	Cross Street: E_INDEPENDENCE/BRIAR_CREEK_RA	Location: SW
ADA ID: 43257D2F18FE	Ramp Type: Perp	Initial Pass/Fail: Fail	Overall Compliance: No
Severity Score: 33.75			
Codes/Mitigation Info/Possible Solution		Field Measurements/Component Compliance

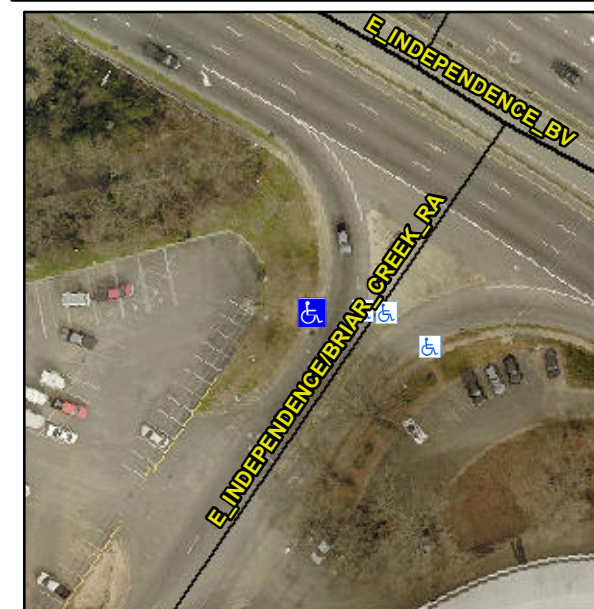
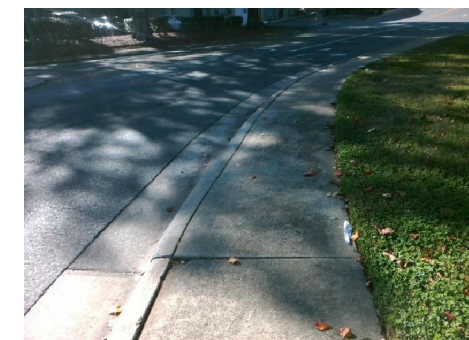
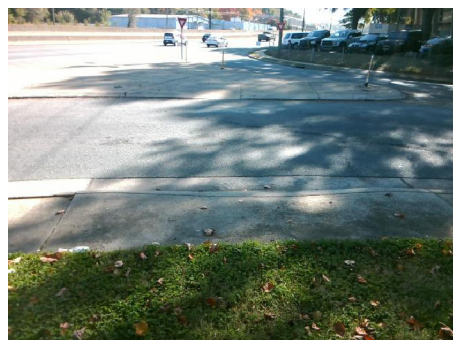
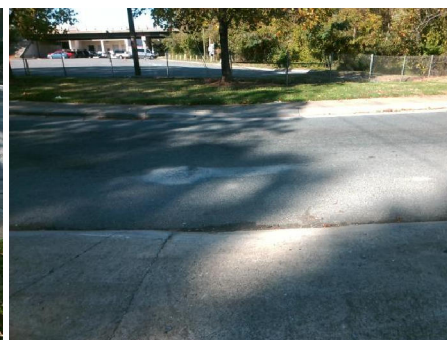
Not Found, R304.5.1, R304.2.2

Compliance	Description	Data	Compliance	Description	Data
N/A	Ramp Length (in)	49.0	No	Ramp Slope (%)	12.3
No	Ramp Width (in)	36.0	Yes	Ramp XSlope (%)	0.0
N/A	Flare Type LT	N/A	N/A	Flare Type RT	N/A
N/A	Flare Slope LT (%)	N/A	N/A	Flare Slope RT (%)	N/A
N/A	Flare Traversable LT?	N/A	N/A	Flare Traversable RT?	N/A
N/A	Landing Length (in)	N/A	N/A	DWS Provided?	N/A
N/A	Landing Width (in)	N/A	N/A	DWS Contrast?	N/A
N/A	Landing Slope (%)	N/A	N/A	DWS Length (in)	N/A
N/A	Landing X Slope (%)	N/A	N/A	DWS Full Width?	N/A
N/A	Landing Curb? (Y/N)	N/A	N/A	DWS Offset (in)	N/A
N/A	Shared Landing?	N/A			
N/A	Gutter Ponding?	N/A	N/A	Gutter Slope (%)	N/A
N/A	Gutter Lip Ht (in)	N/A	N/A	Gutter X Slope (%)	N/A
N/A	Painted X Walk1?	No	N/A	Painted X Walk2?	N/A
	X Walk 1 Direction	To E		X Walk 2 Direction	N/A
N/A	X Walk 1 Width (in)	N/A	N/A	X Walk 2 Width (in)	N/A
	X Walk 1 Slope (%)	3.1		X Walk 2 Slope (%)	N/A
	X Walk 1 X Slope (%)	1.0		X Walk 2 X Slope (%)	N/A

N/A	Ramp inside XWalk1?	N/A	N/A	Ramp inside XWalk2?	N/A
	Road Slope (%)	N/A	N/A	Clear Space?	N/A
	Road X Slope (%)	N/A	N/A	Clear Space to XWalk (in)	N/A
N/A	Any Obstructions?	N/A	N/A	Storm Grate/Utility Hazard?	N/A
	Obstruction Type			Storm Grate/Utility Type	
		N/A			N/A
			Yes	Surface Condition? (G/P)	Good

Remove & Replace Entire Ramp.

Total Cost: \$ 1850.00
