| Intersection ID: 3653 | Main Street: TAVERNAY_PY | Cross Street: TREYMORE_LN | Location: | NE |
| ADA ID: 432E44B02087 | Ramp Type: Perp | Initial Pass/Fail: Fail | Overall Compliance: No | Severity Score: 12.5 |

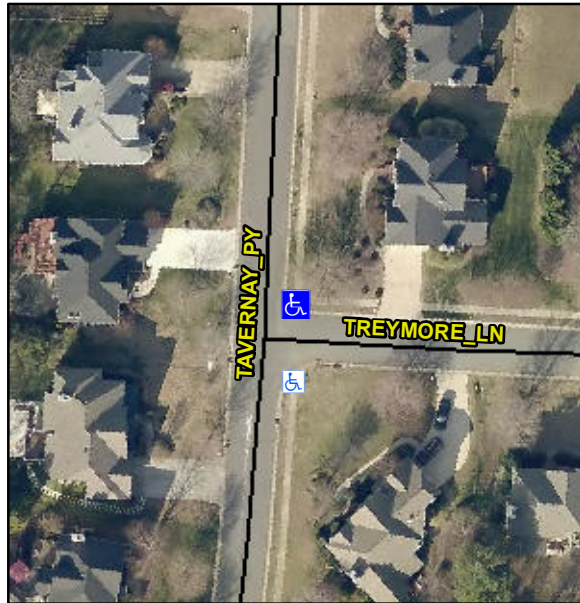
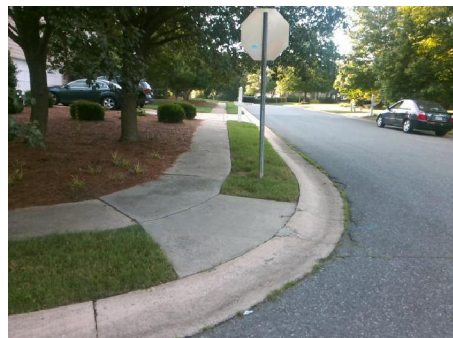
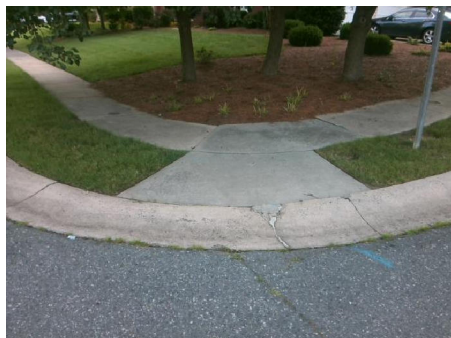
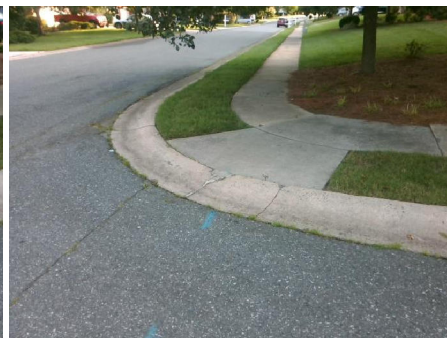
Not Found, R304.5.3

| Possible Solutions: | | | Compliance | Description | Data | Compliance | Description | Data |
|--|--|--|---|---|---|---|---|---|
| | | | Yes | Ramp Width (in) | 60.0 | No | Ramp XSlope (%) | 5.4 |

Remove & Replace Entire Ramp.
