Access Compliance Report

Public Rights-of-Way

(Curb Ramps)

Intersection ID: N/A	Main Street: TWITTER_LN	Cross Street: ROCKY_RIVER_RD	Location: NE
ADA ID: 433B07ED99FC	Ramp Type: Para	Initial Pass/Fail: Fail	Overall Compliance: No
		Severity Score: 12.5

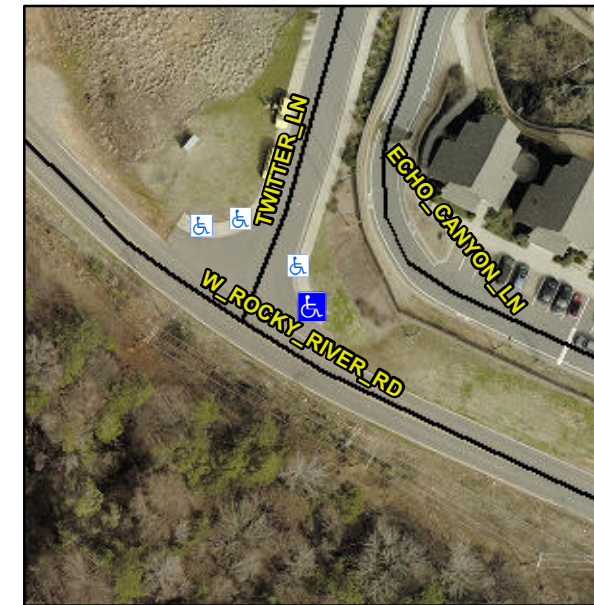
RT RP < 5%

R304.3.2

Compliance	Description	Data	Compliance	Description	Data
N/A	Ramp Length LT (in)	55.0	N/A	Ramp Length RT (in)	59.0
Yes	Ramp Width LT (in)	60.0	Yes	Ramp Width RT (in)	60.0
No	Ramp Slope LT (%)	9.1	Yes	Ramp Slope RT (%)	2.1
Yes	Ramp XSlope LT (%)	1.7	Yes	Ramp XSlope RT (%)	0.5
N/A	Landing Length (in)	N/A	N/A	DWS Provided?	N/A
N/A	Landing Width (in)	N/A	N/A	DWS Contrast?	N/A
N/A	Landing Slope (%)	N/A	N/A	DWS Length (in)	N/A
N/A	Landing X Slope (%)	N/A	N/A	DWS Full Width?	N/A
N/A	Landing Curb? (Y/N)	N/A	N/A	DWS Offset (in)	N/A
N/A	Shared Landing?	N/A			
N/A	Gutter Ponding?	N/A	N/A	Gutter Slope (%)	N/A
N/A	Gutter Lip Ht (in)	N/A	N/A	Gutter X Slope (%)	N/A
N/A	Painted X Walk1?	No	N/A	Painted X Walk2?	N/A
	X Walk 1 Direction	To S		X Walk 2 Direction	N/A
N/A	X Walk 1 Width (in)	N/A	N/A	X Walk 2 Width (in)	N/A
	X Walk 1 Slope (%)	3.0		X Walk 2 Slope (%)	N/A
	X Walk 1 X Slope (%)	1.3		X Walk 2 X Slope (%)	N/A
N/A	Ramp inside XWalk1?	N/A	N/A	Ramp inside XWalk2?	N/A

Remove & Replace Entire Ramp.
