Access Compliance Report

Public Rights-of-Way

(Curb Ramps)

Intersection ID: 16267	Main Street: BEAM_RD	Cross Street: YORKMONT_RD	Location: NE
ADA ID: 4344D77BB36D	Ramp Type: Perp	Initial Pass/Fail: Fail	Overall Compliance: No
Severity Score: 22.5			
Codes/Mitigation Info/Possible Solution		Field Measurements/Component Compliance

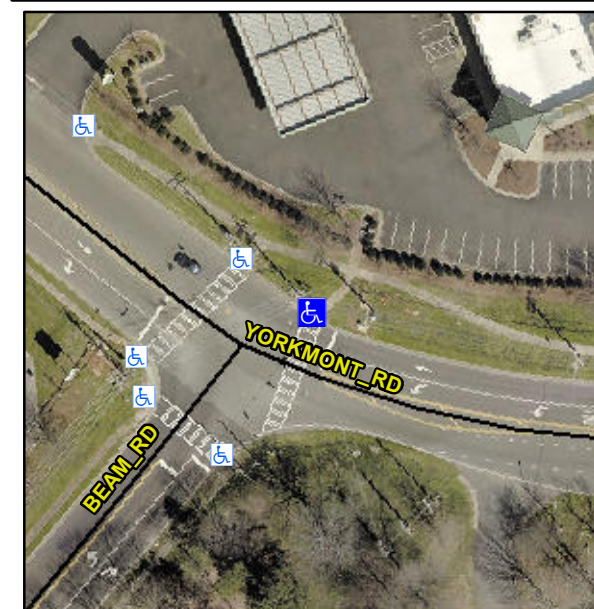
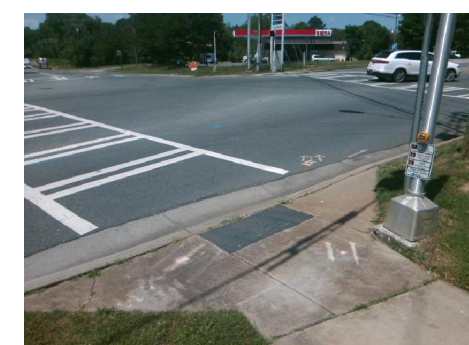
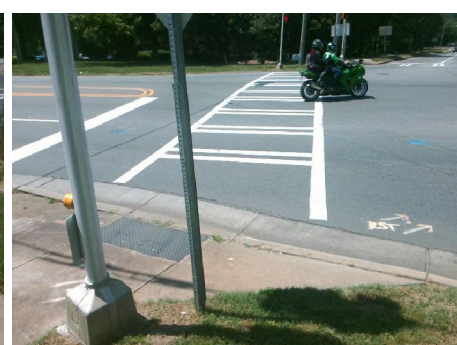
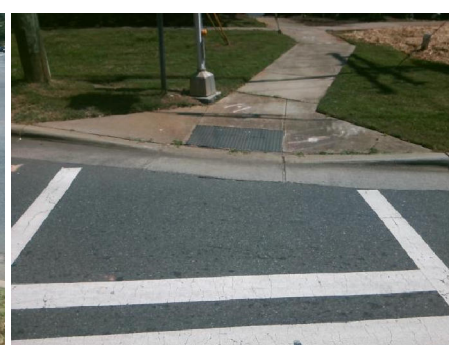
Not Found, R304.5.1, R304.2.2, R304.5.3

Compliance	Description	Data	Compliance	Description	Data
N/A	Ramp Length (in)	83.0	No	Ramp Slope (%)	11.1
No	Ramp Width (in)	46.5	No	Ramp XSlope (%)	4.5
N/A	Flare Type LT	N/A	N/A	Flare Type RT	N/A
N/A	Flare Slope LT (%)	N/A	N/A	Flare Slope RT (%)	N/A
N/A	Flare Traversable LT?	N/A	N/A	Flare Traversable RT?	N/A
N/A	Landing Length (in)	N/A	N/A	DWS Provided?	N/A
N/A	Landing Width (in)	N/A	N/A	DWS Contrast?	N/A
N/A	Landing Slope (%)	N/A	N/A	DWS Length (in)	N/A
N/A	Landing X Slope (%)	N/A	N/A	DWS Full Width?	N/A
N/A	Landing Curb? (Y/N)	N/A	N/A	DWS Offset (in)	N/A
N/A	Shared Landing?	N/A			
N/A	Gutter Ponding?	N/A	N/A	Gutter Slope (%)	N/A
N/A	Gutter Lip Ht (in)	N/A	N/A	Gutter X Slope (%)	N/A
N/A	Painted X Walk1?	Yes	N/A	Painted X Walk2?	N/A
	X Walk 1 Direction	To SW		X Walk 2 Direction	N/A
N/A	X Walk 1 Width (in)	109.0	N/A	X Walk 2 Width (in)	N/A
	X Walk 1 Slope (%)	2.9		X Walk 2 Slope (%)	N/A
	X Walk 1 X Slope (%)	2.4		X Walk 2 X Slope (%)	N/A

N/A	Ramp inside XWalk1?	Yes	N/A	Ramp inside XWalk2?	N/A
	Road Slope (%)	N/A	N/A	Clear Space?	N/A
	Road X Slope (%)	N/A	N/A	Clear Space to XWalk (in)	N/A
N/A	Any Obstructions?	N/A	N/A	Storm Grate/Utility Hazard?	N/A
	Obstruction Type			Storm Grate/Utility Type	
		N/A			N/A
			Yes	Surface Condition? (G/P)	Good

Possible Solutions:

Remove & Replace Entire Ramp.
