# Access Compliance Report

## Public Rights-of-Way

### (Curb Ramps)

| Intersection ID: 8447 | Main Street: CENTRE_ST | Cross Street: KENTUCKY_AV | Location: SE |

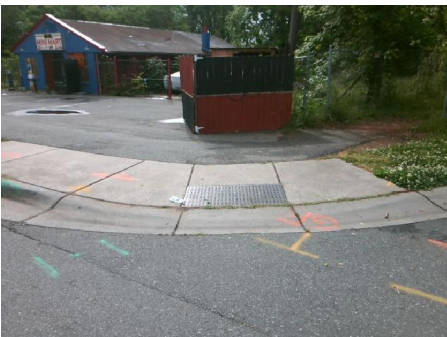
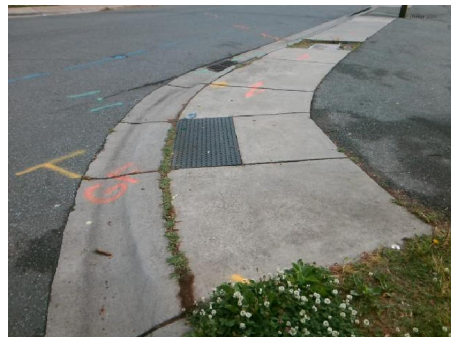
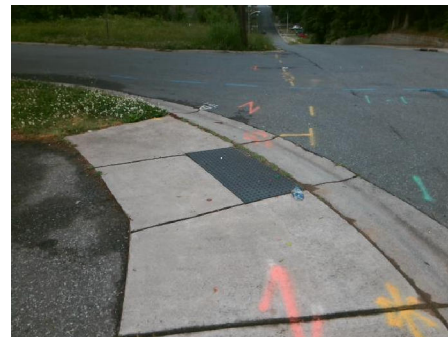
**NO RT SW**

**Not Found, R304.2.1, R304.2.2-Perp, R304.3.2-Para, R304.5.4**

| Compliance | Description | Data | Compliance | Description | Data |
|---|---|---|---|---|---|
| No | Landing Length (in) | 36.0 | Yes | DWS Provided? | Yes |
| No | Landing Slope (%) | 3.3 | Yes | DWS Length (in) | 24.0 |
| Yes | Gutter Ponding? | No | No | Gutter Slope (%) | 7.5 |
| | | | No | Curb Slope (%) | 13.7 |

**Remove & Replace Curb Ramp With Two New Directional Ramps or Equivalent. Remove & Replace Gutter.**
