Access Compliance Report

Public Rights-of-Way

(Curb Ramps)

Intersection ID: 7128	Main Street: DALECREST_DR	Cross Street: KENMONT_DR	Location: S
ADA ID: 434CEDA386F0	Ramp Type: BlendTrans1	Initial Pass/Fail: Fail	Overall Compliance: No
Severity Score: 18.75			
Codes/Mitigation Info/Possible Solution		Field Measurements/Component Compliance

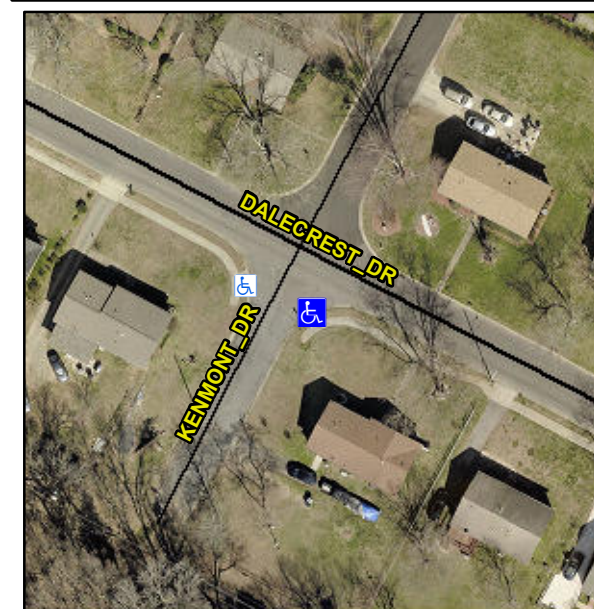
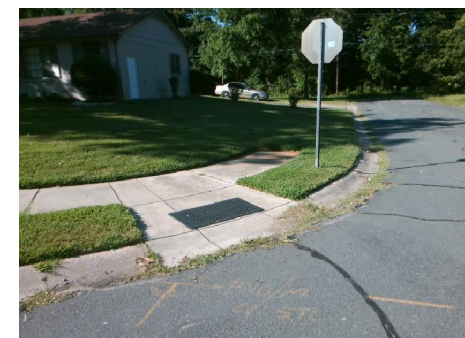
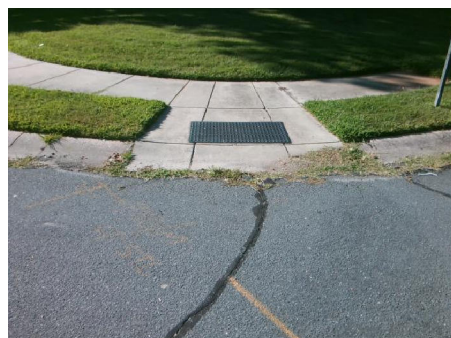
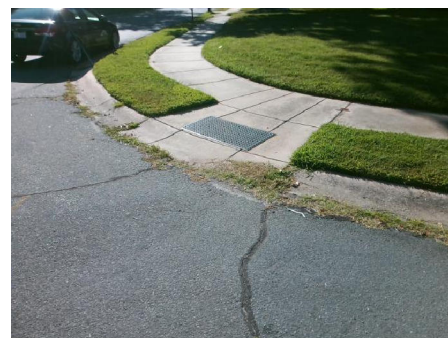
Not Found, R304.5.1, R304.5.3

Compliance	Description	Data	Compliance	Description	Data
N/A	Ramp Length (in)	47.5	Yes	BlendTrans Slope (%)	4.7
No	Ramp Width (in)	34.5	No	BlendTrans XSlope (%)	2.6
N/A	Flare Type LT	N/A	N/A	Flare Type RT	N/A
N/A	Flare Slope LT (%)	N/A	N/A	Flare Slope RT (%)	N/A
N/A	Flare Traversable LT?	N/A	N/A	Flare Traversable RT?	N/A
N/A	Landing Length (in)	N/A	N/A	DWS Provided?	N/A
N/A	Landing Width (in)	N/A	N/A	DWS Contrast?	N/A
N/A	Landing Slope (%)	N/A	N/A	DWS Length (in)	N/A
N/A	Landing X Slope (%)	N/A	N/A	DWS Full Width?	N/A
N/A	Landing Curb? (Y/N)	N/A	N/A	DWS Offset (in)	N/A
N/A	Shared Landing?	N/A			
N/A	Gutter Ponding?	N/A	N/A	Gutter Slope (%)	N/A
N/A	Gutter Lip Ht (in)	N/A	N/A	Gutter X Slope (%)	N/A
N/A	Painted X Walk1?	No	N/A	Painted X Walk2?	N/A
	X Walk 1 Direction	To NW		X Walk 2 Direction	N/A
	X Walk 1 Width (in)	N/A		X Walk 2 Width (in)	N/A
	X Walk 1 Slope (%)	1.4		X Walk 2 Slope (%)	N/A
	X Walk 1 X Slope (%)	3.3		X Walk 2 X Slope (%)	N/A

N/A	Ramp inside XWalk1?	N/A	N/A	Ramp inside XWalk2?	N/A
	Road Slope (%)	3.3		Clear Space?	N/A
	Road X Slope (%)	1.4	N/A	Clear Space to XWalk (in)	N/A
N/A	Any Obstructions?	N/A	N/A	Storm Grate/Utility Hazard?	N/A
	Obstruction Type			Storm Grate/Utility Type	
		N/A			N/A
			Yes	Surface Condition? (G/P)	Good
			No	Curb Slope (%)	17.2

Remove & Replace Curb Ramp With Two New Directional Ramps or Equivalent.
