Access Compliance Report

Public Rights-of-Way

(Curb Ramps)

Intersection ID: 14378	Main Street: WORTHINGTON_AV	Cross Street: EUCLID_AV	Location:	N
ADA ID: 434DD467D639	Ramp Type: Perp	Initial Pass/Fail: Fail	Overall Compliance: No	Severity Score: 1.25
Codes/Mitigation Info/Possible Solution		Field Measurements/Component Compliance

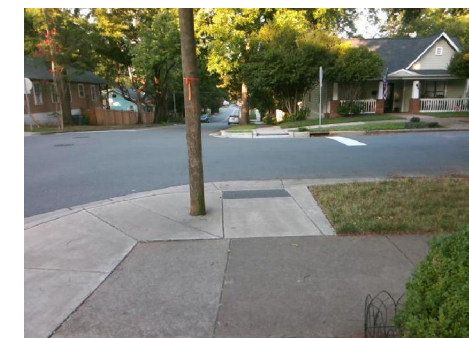
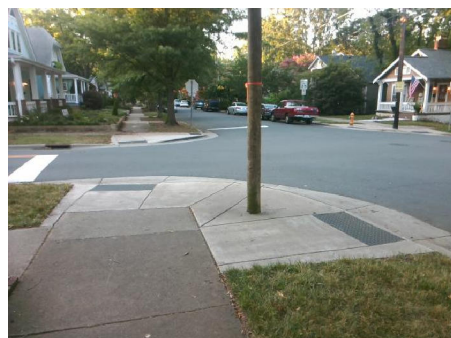
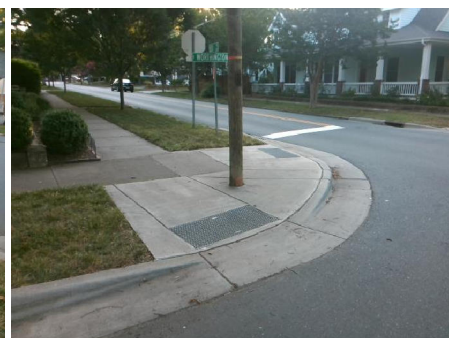
Compliance	Description	Data	Compliance	Description	Data
N/A	Ramp Length (in)	101.0	Yes	Ramp Slope (%)	5.1
Yes	Ramp Width (in)	48.0	No	Ramp XSlope (%)	2.5
N/A	Flare Type LT	N/A	N/A	Flare Type RT	N/A
N/A	Flare Slope LT (%)	N/A	N/A	Flare Slope RT (%)	N/A
N/A	Flare Traversable LT?	N/A	N/A	Flare Traversable RT?	N/A
N/A	Landing Length (in)	N/A	N/A	DWS Provided?	N/A
N/A	Landing Width (in)	N/A	N/A	DWS Contrast?	N/A
N/A	Landing Slope (%)	N/A	N/A	DWS Length (in)	N/A
N/A	Landing X Slope (%)	N/A	N/A	DWS Full Width?	N/A
N/A	Landing Curb? (Y/N)	N/A	N/A	DWS Offset (in)	N/A
N/A	Shared Landing?	N/A			
N/A	Gutter Ponding?	N/A	N/A	Gutter Slope (%)	N/A
N/A	Gutter Lip Ht (in)	N/A	N/A	Gutter X Slope (%)	N/A
N/A	Painted X Walk1?	No	N/A	Painted X Walk2?	N/A
	X Walk 1 Direction	To SW		X Walk 2 Direction	N/A
N/A	X Walk 1 Width (in)	N/A	N/A	X Walk 2 Width (in)	N/A
	X Walk 1 Slope (%)	3.3		X Walk 2 Slope (%)	N/A
	X Walk 1 X Slope (%)	0.9		X Walk 2 X Slope (%)	N/A

N/A	Ramp inside XWalk1?	N/A	N/A	Ramp inside XWalk2?	N/A
	Road Slope (%)	N/A	N/A	Clear Space?	N/A
	Road X Slope (%)	N/A	N/A	Clear Space to XWalk (in)	N/A
N/A	Any Obstructions?	N/A	N/A	Storm Grate/Utility Hazard?	N/A
	Obstruction Type			Storm Grate/Utility Type	
		N/A			N/A
			Yes	Surface Condition? (G/P)	Good

Remove & Replace Entire Ramp.

R304.5.3
