# Access Compliance Report

## Public Rights-of-Way

| Intersection ID: 7379 | Main Street: SQUIRREL_HILL_RD | Cross Street: VANCOUVER_DR | Location: NE |
| ADA ID: 438D9251CD53 | Ramp Type: Perp | Initial Pass/Fail: Fail | Overall Compliance: No |

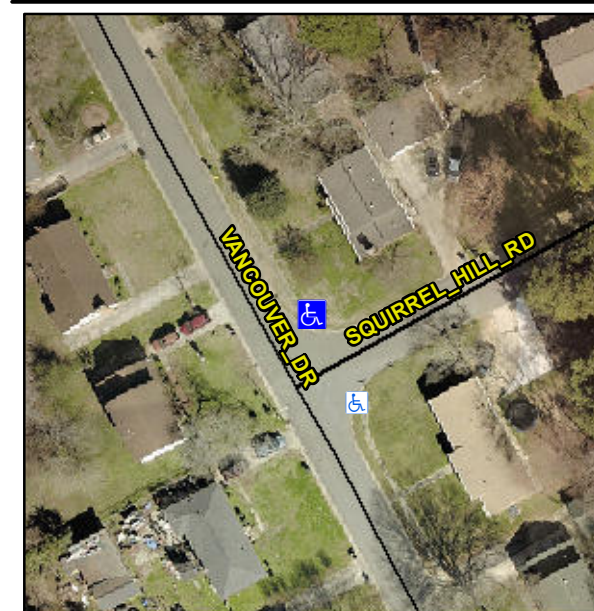
| Severity Score: 8.75 | | | |

**Not Found, R304.5.1**

| Compliance | Description | Data | Compliance | Description | Data |
|---|---|---|---|---|---|
| N/A | Ramp Length (in) | 48.5 | Yes | Ramp Slope (%) | 5.7 |
| No | Ramp Width (in) | 39.5 | Yes | Ramp XSlope (%) | 0.1 |

**Remove & Replace Entire Ramp.**

Total Cost: \$ 1850.00
