Access Compliance Report

Public Rights-of-Way

(Curb Ramps)

Intersection ID: 46321	Main Street: MAGNASCO_LN	Cross Street: MANES_CT	Location:	N
ADA ID: 438F36C593C0	Ramp Type: PerpDiag	Initial Pass/Fail: Fail	Overall Compliance: No	Severity Score: 13.75

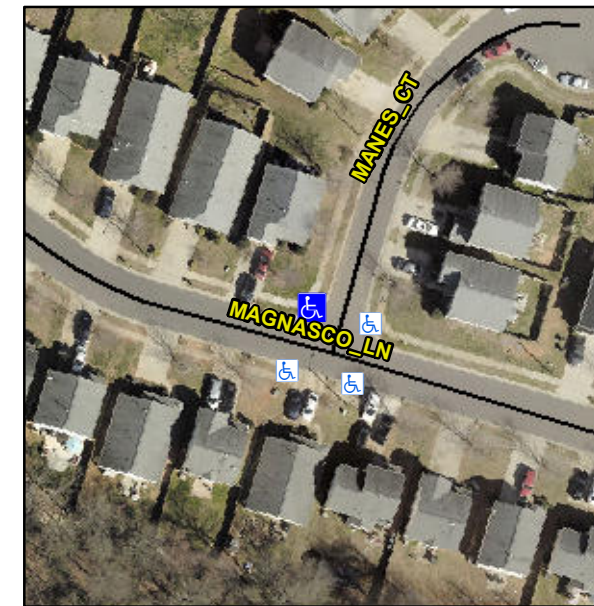
Compliance	Description	Data	Compliance	Description	Data
N/A	Ramp Length (in)	54.0	No	Ramp Slope (%)	10.3
Yes	Ramp Width (in)	48.0	No	Ramp XSlope (%)	3.7
N/A	Flare Type LT	N/A	N/A	Flare Type RT	N/A
N/A	Flare Slope LT (%)	N/A	N/A	Flare Slope RT (%)	N/A
N/A	Flare Traversable LT?	N/A	N/A	Flare Traversable RT?	N/A
N/A	Landing Length (in)	N/A	N/A	DWS Provided?	N/A
N/A	Landing Width (in)	N/A	N/A	DWS Contrast?	N/A
N/A	Landing Slope (%)	N/A	N/A	DWS Length (in)	N/A
N/A	Landing X Slope (%)	N/A	N/A	DWS Full Width?	N/A
N/A	Landing Curb? (Y/N)	N/A	N/A	DWS Offset (in)	N/A
N/A	Shared Landing?	N/A			
N/A	Gutter Ponding?	N/A	N/A	Gutter Slope (%)	N/A
N/A	Gutter Lip Ht (in)	N/A	N/A	Gutter X Slope (%)	N/A
N/A	Painted X Walk1?	No	N/A	Painted X Walk2?	No
	X Walk 1 Direction	To SW		X Walk 2 Direction	To SE
N/A	X Walk 1 Width (in)	N/A	N/A	X Walk 2 Width (in)	N/A
	X Walk 1 Slope (%)	4.0		X Walk 2 Slope (%)	2.6
	X Walk 1 X Slope (%)	5.3		X Walk 2 X Slope (%)	1.2

N/A	Ramp inside XWalk1?	N/A	N/A	Ramp inside XWalk2?	N/A
	Road Slope (%)	4.6	N/A	Clear Space?	N/A
	Road X Slope (%)	1.0	N/A	Clear Space to XWalk (in)	N/A
N/A	Any Obstructions?	N/A	N/A	Storm Grate/Utility Hazard?	N/A
	Obstruction Type			Storm Grate/Utility Type	
		N/A			N/A
			Yes	Surface Condition? (G/P)	Good

Remove & Replace Curb Ramp With Two New Directional Ramps or Equivalent.

Not Found, R304.2.2, R304.5.3
