## **Access Compliance Report Public Rights-of-Way** (Curb Ramps)

Intersection ID: 21746 Main Street: INTERNATIONAL DR **Cross Street: PROVIDENCE\_RD** Location: SE **Overall Compliance: No ADA ID: 439C5EDF3A1E** Ramp Type: BlendTrans1 Initial Pass/Fail: Fail **Severity Score:** 10

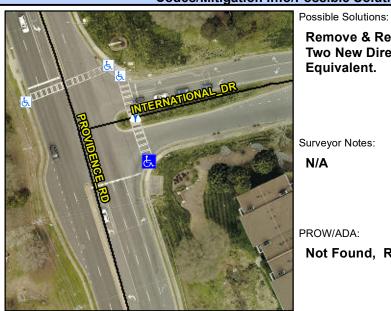
Not Found, R304.5.1

Field Measurements/Component Compliance						
Compliance Description		Data	Comp	liance Description	Data	
N/A	Ramp Length (in)	24.0	Yes	BlendTrans Slope (%)	2.3	
No	Ramp Width (in)	46.0	Yes	BlendTrans XSlope (%)	2.2	
N/A	Flare Type LT	N/A	N/A	Flare Type RT	N/A	
N/A	Flare Slope LT (%)	N/A	N/A	Flare Slope RT (%)	N/A	
N/A	Flare Traversable LT?	N/A	N/A	Flare Traversable RT?	N/A	
N/A	Landing Length (in)	N/A	N/A	DWS Provided?	N/A	
N/A	Landing Width (in)	N/A	N/A	DWS Contrast?	N/A	
N/A	Landing Slope (%)	N/A	N/A	DWS Length (in)	N/A	
N/A	Landing X Slope (%)	N/A	N/A	DWS Full Width?	N/A	
N/A	Landing Curb? (Y/N)	N/A	N/A	DWS Offset (in)	N/A	
N/A	Shared Landing?	N/A				
N/A	Gutter Ponding?	N/A	N/A	Gutter Slope (%)	N/A	
N/A	Gutter Lip Ht (in)	N/A	N/A	Gutter X Slope (%)	N/A	
N/A	Painted X Walk1?	Yes	N/A	Painted X Walk2?	N/A	
	X Walk 1 Direction	To N		X Walk 2 Direction	N/A	
	X Walk 1 Width (in)	114.0		X Walk 2 Width (in)	N/A

X Walk 1 Slope (%)	8.1		X Walk 2 Slope (%)	N/A	
	X Walk 1 X Slope (%)	3.8		X Walk 2 X Slope (%)	N/A	
N/A	Ramp inside XWalk1?	Yes	N/A	Ramp inside XWalk2?	N/A	
	Road Slope (%)	3.8		Clear Space?	N/A	
	Road X Slope (%)	8.1	N/A	Clear Space to XWalk (in)	N/A	
N/A	Any Obstructions?	N/A	N/A	Storm Grate/Utility Hazard?	N/A	
	Obstruction Type			Storm Grate/Utility Type		
		N/A			N/A	
			Yes	Surface Condition? (G/P)	Good

40.00			No	Curb Slope (%)	11.5

**Remove & Replace Curb Ramp With Two New Directional Ramps or** Equivalent.
