Access Compliance Report

Public Rights-of-Way

(Curb Ramps)

Intersection ID: 23302	Main Street: COLONY_RD	Cross Street: MORROWICK_RD	Location: NW
ADA ID: 43B1C24BC6A0	Ramp Type: PerpDiag	Initial Pass/Fail: Fail	Overall Compliance: No
			Severity Score: 21.25

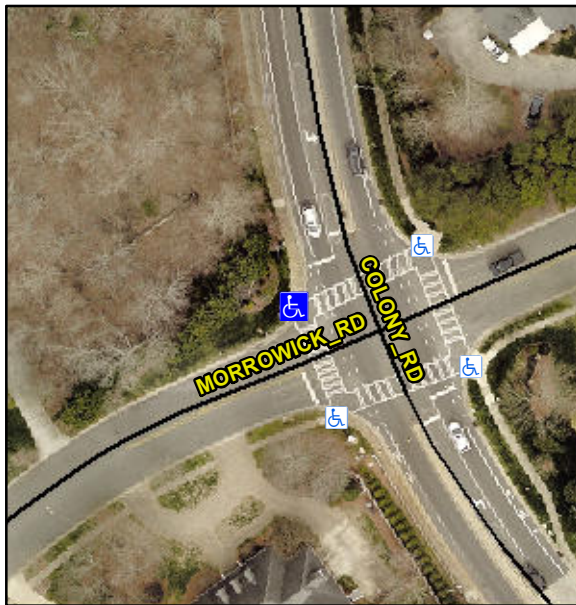
Compliance	Description	Data	Compliance	Description	Data
N/A	Ramp Length (in)	71.0	No	Ramp Slope (%)	8.5
No	Ramp Width (in)	40.0	Yes	Ramp XSlope (%)	0.9
N/A	Flare Type LT	N/A	N/A	Flare Type RT	N/A
N/A	Flare Slope LT (%)	N/A	N/A	Flare Slope RT (%)	N/A
N/A	Flare Traversable LT?	N/A	N/A	Flare Traversable RT?	N/A
N/A	Landing Length (in)	N/A	N/A	DWS Provided?	N/A
N/A	Landing Width (in)	N/A	N/A	DWS Contrast?	N/A
N/A	Landing Slope (%)	N/A	N/A	DWS Length (in)	N/A
N/A	Landing X Slope (%)	N/A	N/A	DWS Full Width?	N/A
N/A	Landing Curb? (Y/N)	N/A	N/A	DWS Offset (in)	N/A
N/A	Shared Landing?	N/A			
N/A	Gutter Ponding?	N/A	N/A	Gutter Slope (%)	N/A
N/A	Gutter Lip Ht (in)	N/A	N/A	Gutter X Slope (%)	N/A
N/A	Painted X Walk1?	Yes	N/A	Painted X Walk2?	Yes
	X Walk 1 Direction	To S		X Walk 2 Direction	To NE
N/A	X Walk 1 Width (in)	107.0	N/A	X Walk 2 Width (in)	109.0
	X Walk 1 Slope (%)	3.9		X Walk 2 Slope (%)	2.1
	X Walk 1 X Slope (%)	2.2		X Walk 2 X Slope (%)	4.5

N/A	Ramp inside XWalk1?	Yes	N/A	Ramp inside XWalk2?	Yes
	Road Slope (%)	1.1	N/A	Clear Space?	N/A
	Road X Slope (%)	5.0	N/A	Clear Space to XWalk (in)	N/A
N/A	Any Obstructions?	N/A	N/A	Storm Grate/Utility Hazard?	N/A
	Obstruction Type			Storm Grate/Utility Type	
		N/A			N/A
		Yes		Surface Condition? (G/P)	Good

Possible Solutions:

Remove & Replace Curb Ramp With Two New Directional Ramps or Equivalent.
