Access Compliance Report

Public Rights-of-Way

(Curb Ramps)

Intersection ID: 12413	Main Street: N_BREVARD_ST	Cross Street: E_6TH_ST	Location: S
ADA ID: 43BA466E18AA	Ramp Type: Perp	Initial Pass/Fail: Pass	Overall Compliance: No
Severity Score: 2.5			
Codes/Mitigation Info/Possible Solution		Field Measurements/Component Compliance

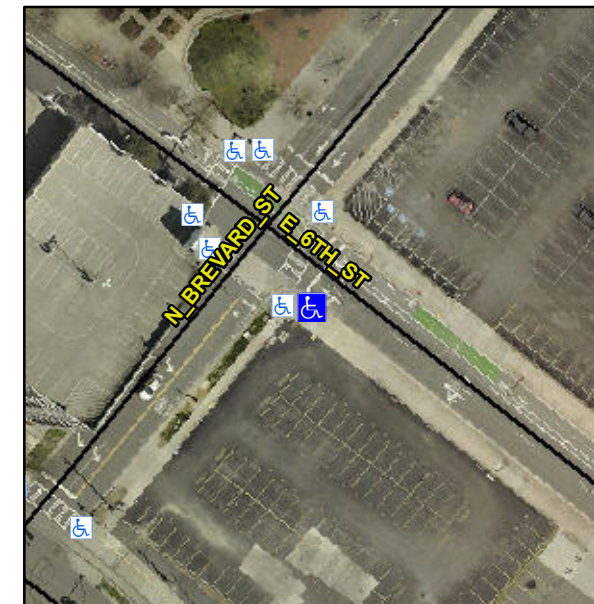
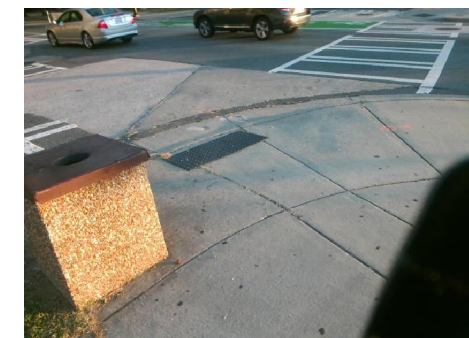
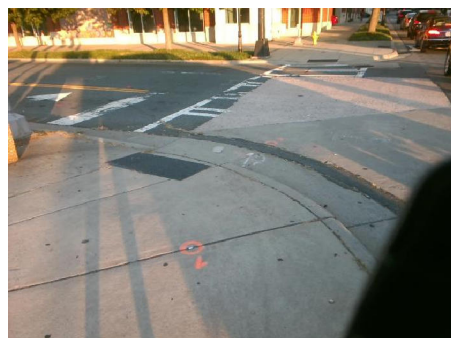
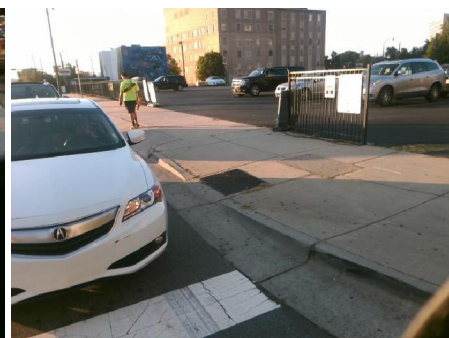
Not Found, R305.1.4

Compliance	Description	Data	Compliance	Description	Data
N/A	Ramp Length (in)	68.0	Yes	Ramp Slope (%)	7.7
Yes	Ramp Width (in)	48.0	Yes	Ramp XSlope (%)	1.0
N/A	Flare Type LT	Sloped	N/A	Flare Type RT	N/A
N/A	Flare Slope LT (%)	2.9	Yes	Flare Slope RT (%)	4.6
N/A	Flare Traversable LT?	Yes	N/A	Flare Traversable RT?	Yes
Yes	Landing Length (in)	48.0	Yes	DWS Provided?	Yes
Yes	Landing Width (in)	48.0	Yes	DWS Contrast?	Yes
Yes	Landing Slope (%)	0.7	Yes	DWS Length (in)	28.0
Yes	Landing X Slope (%)	0.1	No	DWS Full Width?	No
N/A	Landing Curb? (Y/N)	No	Yes	DWS Offset (in)	0.0
N/A	Shared Landing?	No			
Yes	Gutter Ponding?	No	Yes	Gutter Slope (%)	4.3
Yes	Gutter Lip Ht (in)	0.0	Yes	Gutter X Slope (%)	1.3
N/A	Painted X Walk1?	No	N/A	Painted X Walk2?	N/A
	X Walk 1 Direction	To NE		X Walk 2 Direction	N/A
N/A	X Walk 1 Width (in)	N/A	N/A	X Walk 2 Width (in)	N/A
	X Walk 1 Slope (%)	1.5		X Walk 2 Slope (%)	N/A
	X Walk 1 X Slope (%)	0.6		X Walk 2 X Slope (%)	N/A

N/A	Ramp inside XWalk1?	N/A	N/A	Ramp inside XWalk2?	N/A
	Road Slope (%)	N/A	N/A	Clear Space?	Yes
	Road X Slope (%)	N/A	N/A	Clear Space to XWalk (in)	N/A
Yes	Any Obstructions?	No	Yes	Storm Grate/Utility Hazard?	No
	Obstruction Type			Storm Grate/Utility Type	
		N/A			N/A
			Yes	Surface Condition? (G/P)	Good

Remove & Replace Entire Ramp.
