Access Compliance Report

Public Rights-of-Way

(Curb Ramps)

Intersection ID: 8315	Main Street: BRADFORD_DR	Cross Street: HOVIS_RD	Location:	E
ADA ID: 43BEB513F2A4	Ramp Type: BlendTrans2	Initial Pass/Fail: Fail	Overall Compliance: No	Severity Score: 8.75

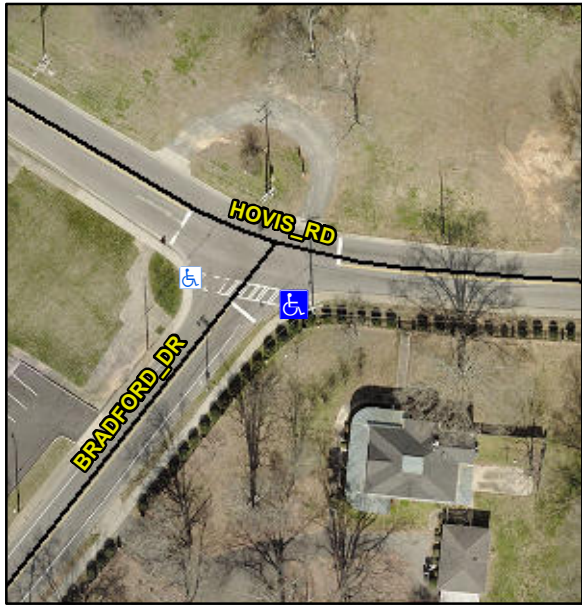
Possible Solutions:		Compliance	Description	Data	Compliance	Description	Data
	Remove & Replace Curb Ramp With Two New Directional Ramps or Equivalent.		N/A	Ramp Length (in)	77.5	Yes	BlendTrans Slope (%)	2.0
			No	Ramp Width (in)	47.5	Yes	BlendTrans XSlope (%)	0.1
			N/A	Flare Type LT	N/A	N/A	Flare Type RT	N/A
			N/A	Flare Slope LT (%)	N/A	N/A	Flare Slope RT (%)	N/A
			N/A	Flare Traversable LT?	N/A	N/A	Flare Traversable RT?	N/A
			N/A	Landing Length (in)	N/A	N/A	DWS Provided?	N/A
			N/A	Landing Width (in)	N/A	N/A	DWS Contrast?	N/A
			N/A	Landing Slope (%)	N/A	N/A	DWS Length (in)	N/A
			N/A	Landing X Slope (%)	N/A	N/A	DWS Full Width?	N/A
Surveyor Notes:	CURB LIP 1.0, STOP SIGN & SIGNAL		N/A	Landing Curb? (Y/N)	N/A	N/A	DWS Offset (in)	N/A
			N/A	Shared Landing?	N/A			
			N/A	Gutter Ponding?	N/A	N/A	Gutter Slope (%)	N/A

N/A	Gutter Lip Ht (in)	N/A	N/A	Gutter X Slope (%)	N/A
			N/A	Painted X Walk1?	Yes	N/A	Painted X Walk2?	N/A
				X Walk 1 Direction	To W		X Walk 2 Direction	N/A
				X Walk 1 Width (in)	94.0		X Walk 2 Width (in)	N/A
				X Walk 1 Slope (%)	0.6		X Walk 2 Slope (%)	N/A
				X Walk 1 X Slope (%)	3.2		X Walk 2 X Slope (%)	N/A
			N/A	Ramp inside XWalk1?	Yes	N/A	Ramp inside XWalk2?	N/A
PROW/ADA:	R304.5.1			Road Slope (%)	3.2		Clear Space?	N/A
				Road X Slope (%)	0.6	N/A	Clear Space to XWalk (in)	N/A
			N/A	Any Obstructions?	N/A	N/A	Storm Grate/Utility Hazard?	N/A
				Obstruction Type			Storm Grate/Utility Type	
						N/A		N/A
						Yes	Surface Condition? (G/P)	Good
						N/A	Curb Slope (%)	3.9
						</
