# Access Compliance Report

## Public Rights-of-Way

### (Curb Ramps)

| Intersection ID: 15074 | Main Street: MAGNOLIA_AV | Cross Street: PARK_RD | Location: NE |

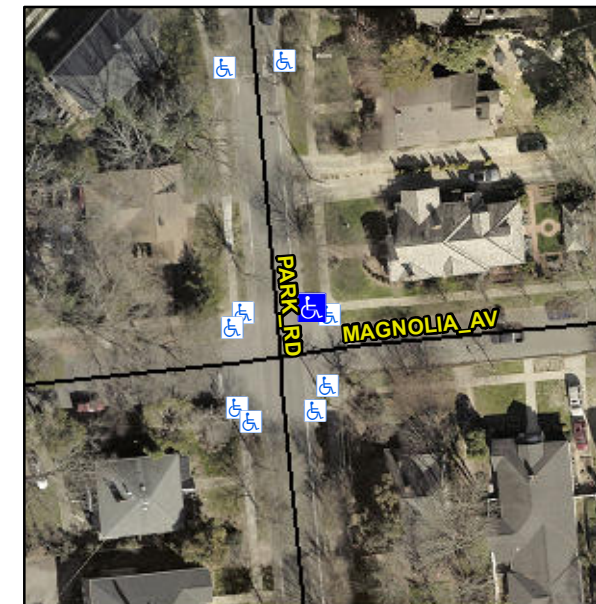
| ADA ID: 43C10248F23D | Ramp Type: Directional1 | Initial Pass/Fail: Pass | Overall Compliance: No |
| | | Severity Score: 17.5 | |

**Not Found, R304.2.2-Perp, R304.3.2-Para, R304.5.3, R304.5.2, R305.1.4, R302.7.2**

| Compliance | Description | Data | Compliance | Description | Data |
|---|---|---|---|---|---|
| No | Landing Slope (%) | 2.2 | Yes | DWS Length (in) | 24.5 |
| No | Landing X Slope (%) | 3.6 | No | DWS Full Width? | No |
| No | Gutter Lip Ht (in) | 1.5 | Yes | Gutter X Slope (%) | 0.6 |

Possible Solutions:

**Remove & Replace Entire Ramp.**

Total Cost: \$ 1600.00
