# Access Compliance Report

## Public Rights-of-Way

### (Curb Ramps)

| Intersection ID: 45240 | Main Street: BEGONIA_DR | Cross Street: BLAZE_MANOR_LN | Location: | N |

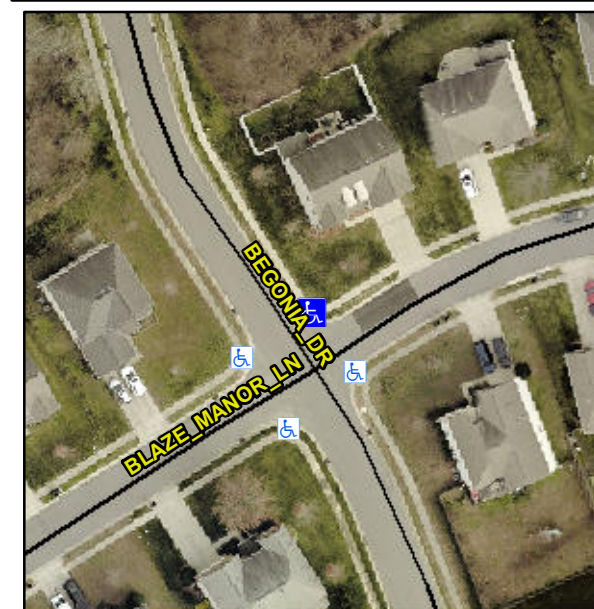
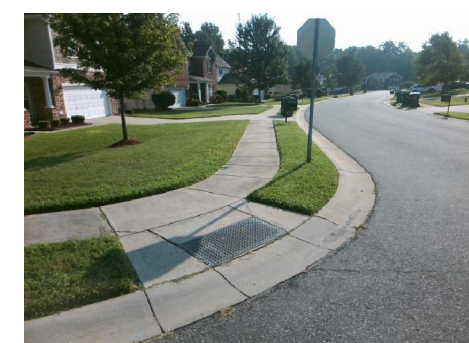
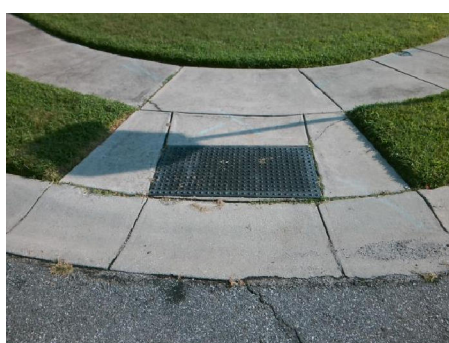
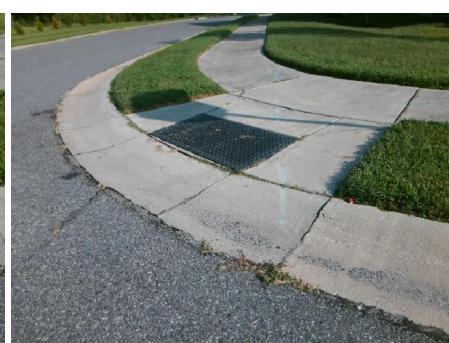
| ADA ID: 43D31868DCD5 | Ramp Type: PerpDiag | Initial Pass/Fail: Pass | Overall Compliance: No | Severity Score: 12.5 |

**Not Found, R302.7, R302.7.2, R304.5.4**

| Compliance | Description | Data | Compliance | Description | Data |
|---|---|---|---|---|---|
| No | Gutter Ponding? | Yes | No | Gutter Slope (%) | 16.6 |
| No | Gutter Lip Ht (in) | 0.5 | Yes | Gutter X Slope (%) | 0.7 |

**Remove & Replace Curb Slope and Extend Ramp. Remove & Replace Gutter.**

Total Cost: \$ 2750.00
