Access Compliance Report

Public Rights-of-Way

(Curb Ramps)

Intersection ID: 49097	Main Street: MINE_SHAFT_LN	Cross Street: E_MALLARD_CREEK_CHURCH_RD	Location: N
ADA ID: 43D49D1E99E8	Ramp Type: Perp	Initial Pass/Fail: Fail	Overall Compliance: No
Severity Score: 13.75			
Codes/Mitigation Info/Possible Solution		Field Measurements/Component Compliance

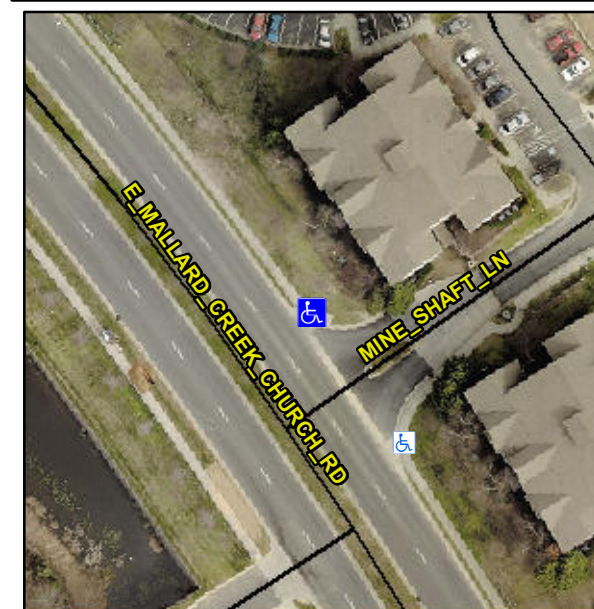
Compliance	Description	Data	Compliance	Description	Data
N/A	Ramp Length (in)	60.5	No	Ramp Slope (%)	10.9
Yes	Ramp Width (in)	49.0	No	Ramp XSlope (%)	4.1
N/A	Flare Type LT	N/A	N/A	Flare Type RT	N/A
N/A	Flare Slope LT (%)	N/A	N/A	Flare Slope RT (%)	N/A
N/A	Flare Traversable LT?	N/A	N/A	Flare Traversable RT?	N/A
N/A	Landing Length (in)	N/A	N/A	DWS Provided?	N/A
N/A	Landing Width (in)	N/A	N/A	DWS Contrast?	N/A
N/A	Landing Slope (%)	N/A	N/A	DWS Length (in)	N/A
N/A	Landing X Slope (%)	N/A	N/A	DWS Full Width?	N/A
N/A	Landing Curb? (Y/N)	N/A	N/A	DWS Offset (in)	N/A
N/A	Shared Landing?	N/A			
N/A	Gutter Ponding?	N/A	N/A	Gutter Slope (%)	N/A
N/A	Gutter Lip Ht (in)	N/A	N/A	Gutter X Slope (%)	N/A
N/A	Painted X Walk1?	No	N/A	Painted X Walk2?	N/A
	X Walk 1 Direction	To SE		X Walk 2 Direction	N/A
N/A	X Walk 1 Width (in)	N/A	N/A	X Walk 2 Width (in)	N/A
	X Walk 1 Slope (%)	0.3		X Walk 2 Slope (%)	N/A
	X Walk 1 X Slope (%)	3.5		X Walk 2 X Slope (%)	N/A

N/A	Ramp inside XWalk1?	N/A	N/A	Ramp inside XWalk2?	N/A
	Road Slope (%)	N/A	N/A	Clear Space?	N/A
	Road X Slope (%)	N/A	N/A	Clear Space to XWalk (in)	N/A
N/A	Any Obstructions?	N/A	N/A	Storm Grate/Utility Hazard?	N/A
	Obstruction Type			Storm Grate/Utility Type	
		N/A			N/A
			Yes	Surface Condition? (G/P)	Good

Possible Solutions:

Remove & Replace Entire Ramp.

R304.2.2, R304.5.3
