# Access Compliance Report

## Public Rights-of-Way

### (Curb Ramps)

Intersection ID: 3720	Main Street: DAVIS_LAKE_PY	Cross Street: FORTUNES_RIDGE_TL	Location:	N
ADA ID: 43ED1E344412	Ramp Type: Perp	Initial Pass/Fail: Fail	Overall Compliance: No	Severity Score: 12.5

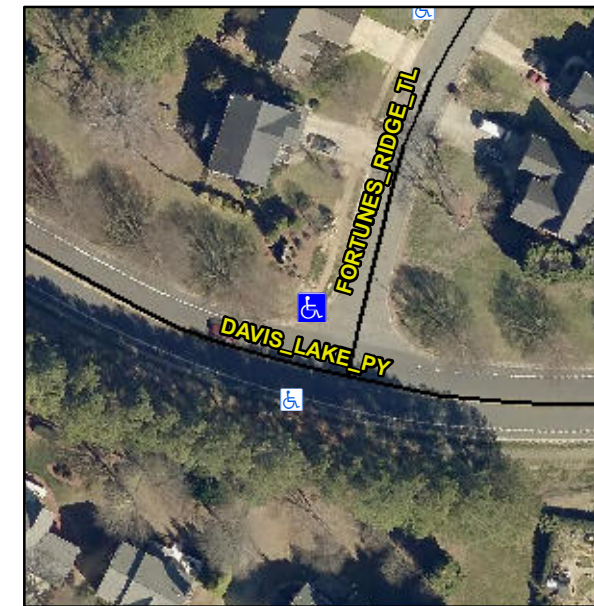
**Not Found, R304.5.3**

Compliance	Description	Data	Compliance	Description	Data
N/A	Ramp Length (in)	54.0	Yes	Ramp Slope (%)	6.4
Yes	Ramp Width (in)	48.0	No	Ramp XSlope (%)	5.6
N/A	Flare Type LT	N/A	N/A	Flare Type RT	N/A
N/A	Flare Slope LT (%)	N/A	N/A	Flare Slope RT (%)	N/A
N/A	Flare Traversable LT?	N/A	N/A	Flare Traversable RT?	N/A
N/A	Landing Length (in)	N/A	N/A	DWS Provided?	N/A
N/A	Landing Width (in)	N/A	N/A	DWS Contrast?	N/A
N/A	Landing Slope (%)	N/A	N/A	DWS Length (in)	N/A
N/A	Landing X Slope (%)	N/A	N/A	DWS Full Width?	N/A
N/A	Landing Curb? (Y/N)	N/A	N/A	DWS Offset (in)	N/A
N/A	Shared Landing?	N/A			
N/A	Gutter Ponding?	N/A	N/A	Gutter Slope (%)	N/A
N/A	Gutter Lip Ht (in)	N/A	N/A	Gutter X Slope (%)	N/A
N/A	Painted X Walk1?	No	N/A	Painted X Walk2?	N/A
	X Walk 1 Direction	To SW		X Walk 2 Direction	N/A
N/A	X Walk 1 Width (in)	N/A	N/A	X Walk 2 Width (in)	N/A
	X Walk 1 Slope (%)	3.9		X Walk 2 Slope (%)	N/A
	X Walk 1 X Slope (%)	2.0		X Walk 2 X Slope (%)	N/A

N/A	Ramp inside XWalk1?	N/A	N/A	Ramp inside XWalk2?	N/A
	Road Slope (%)	N/A	N/A	Clear Space?	N/A
	Road X Slope (%)	N/A	N/A	Clear Space to XWalk (in)	N/A
N/A	Any Obstructions?	N/A	N/A	Storm Grate/Utility Hazard?	N/A
	Obstruction Type			Storm Grate/Utility Type	
		N/A			N/A
			Yes	Surface Condition? (G/P)	Good

**Remove & Replace Entire Ramp.**

Total Cost: \$ 1850.00
