Access Compliance Report

Public Rights-of-Way

(Curb Ramps)

Intersection ID: N/A	Main Street: CHARLOTTE_PARK_DR	Cross Street: N/A	Location: SE
ADA ID: 43F3BB40507A	Ramp Type: PerpDiag	Initial Pass/Fail: Fail	Overall Compliance: No
		Severity Score: 37.5

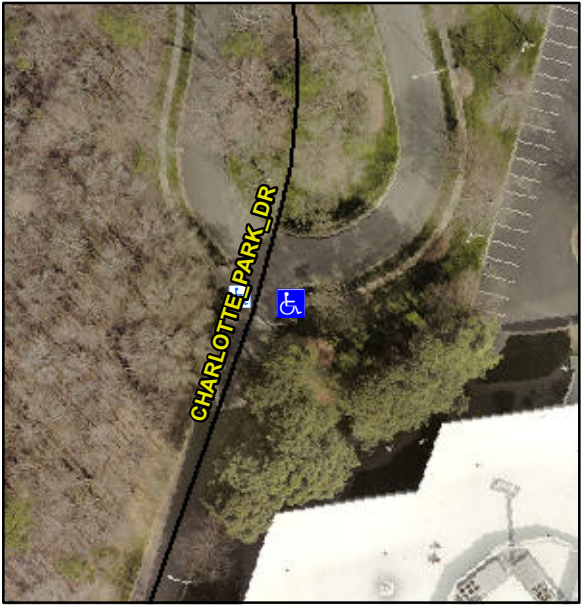
Possible Solutions:		Compliance	Description	Data	
	Remove & Replace Curb Ramp With Two New Directional Ramps or Equivalent.		N/A	Ramp Length (in)	112.0	No
			Yes	Ramp Width (in)	48.0	No
			N/A	Flare Type LT	N/A	N/A
			N/A	Flare Slope LT (%)	N/A	N/A
			N/A	Flare Traversable LT?	No	N/A
			N/A	Landing Length (in)	N/A	N/A
			N/A	Landing Width (in)	N/A	N/A
			N/A	Landing Slope (%)	N/A	N/A
			N/A	Landing X Slope (%)	N/A	N/A
			N/A	Landing Curb? (Y/N)	N/A	N/A
			N/A	Shared Landing?	N/A	
			N/A	Gutter Ponding?	N/A	N/A
			N/A	Gutter Lip Ht (in)	N/A	N/A
			N/A	Painted X Walk1?	No	N/A
				X Walk 1 Direction	To N	
			N/A	X Walk 1 Width (in)	N/A	N/A
				X Walk 1 Slope (%)	3.7	
				X Walk 1 X Slope (%)	1.5	
			N/A	Ramp inside XWalk1?	N/A	N/A
<p>Surveyor Notes:</p> <p>N/A</p> <p>PROW/ADA:</p> <p>R304.2.2, R304.5.3</p>			N/A	Ramp Slope (%)	9.9

Ramp XSlope (%)	7.2	
				Flare Type RT	N/A	
				Flare Slope RT (%)	N/A	
				Flare Traversable RT?	No	
				DWS Provided?	N/A	
				DWS Contrast?	N/A	
				DWS Length (in)	N/A	
				DWS Full Width?	N/A	
				DWS Offset (in)	N/A	
				Gutter Slope (%)	N/A	
				Gutter X Slope (%)	N/A	
				Painted X Walk2?	No	
				X Walk 2 Direction	To W	
				X Walk 2 Width (in)	N/A	
				X Walk 2 Slope (%)	2.9	
				X Walk 2 X Slope (%)	3.8	
				Ramp inside XWalk2?	N/A	
				Clear Space?	N/A	
				Clear Space to XWalk (in)	N/A	
<p>Total Cost:</p> <p>\$ 3200.00</p>			N/A	Storm Grate/Utility Hazard?	N/A	
				Storm Grate/Utility Type		
			N/A			N/A
			Yes	Surface Condition? (G/P)	Good
