Access Compliance Report

Public Rights-of-Way

(Curb Ramps)

Intersection ID: 45862	Main Street: JAMISON_LN	Cross Street: HENDERSON_OAKS_DR	Location: SE
ADA ID: 43F9D44F84FD	Ramp Type: PerpDiag	Initial Pass/Fail: Fail	Overall Compliance: No
Severity Score: 47.5			
Codes/Mitigation Info/Possible Solution		Field Measurements/Component Compliance

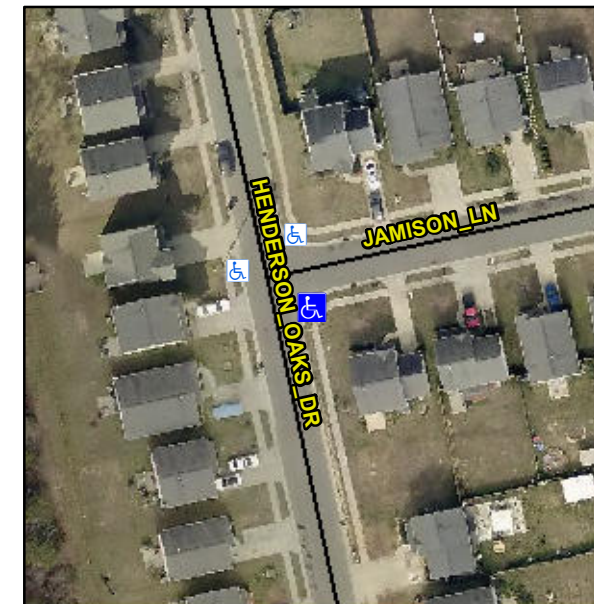
Not Found, R304.5.1, R304.2.2

Compliance	Description	Data	Compliance	Description	Data
N/A	Ramp Length (in)	48.0	No	Ramp Slope (%)	8.5
No	Ramp Width (in)	28.5	Yes	Ramp XSlope (%)	0.6
N/A	Flare Type LT	N/A	N/A	Flare Type RT	N/A
N/A	Flare Slope LT (%)	N/A	N/A	Flare Slope RT (%)	N/A
N/A	Flare Traversable LT?	N/A	N/A	Flare Traversable RT?	N/A
N/A	Landing Length (in)	N/A	N/A	DWS Provided?	N/A
N/A	Landing Width (in)	N/A	N/A	DWS Contrast?	N/A
N/A	Landing Slope (%)	N/A	N/A	DWS Length (in)	N/A
N/A	Landing X Slope (%)	N/A	N/A	DWS Full Width?	N/A
N/A	Landing Curb? (Y/N)	N/A	N/A	DWS Offset (in)	N/A
N/A	Shared Landing?	N/A			
N/A	Gutter Ponding?	N/A	N/A	Gutter Slope (%)	N/A
N/A	Gutter Lip Ht (in)	N/A	N/A	Gutter X Slope (%)	N/A
N/A	Painted X Walk1?	No	N/A	Painted X Walk2?	No
	X Walk 1 Direction	To N		X Walk 2 Direction	To W
N/A	X Walk 1 Width (in)	N/A	N/A	X Walk 2 Width (in)	N/A
	X Walk 1 Slope (%)	4.1		X Walk 2 Slope (%)	2.0
	X Walk 1 X Slope (%)	3.0		X Walk 2 X Slope (%)	1.7

N/A	Ramp inside XWalk1?	N/A	N/A	Ramp inside XWalk2?	N/A
	Road Slope (%)	0.0	N/A	Clear Space?	N/A
	Road X Slope (%)	2.5	N/A	Clear Space to XWalk (in)	N/A
N/A	Any Obstructions?	N/A	N/A	Storm Grate/Utility Hazard?	N/A
	Obstruction Type			Storm Grate/Utility Type	
		N/A			N/A
		Yes		Surface Condition? (G/P)	Good

Remove & Replace Curb Ramp With Two New Directional Ramps or Equivalent.
