Access Compliance Report Public Rights-of-Way (Curb Ramps)

Intersection ID: 10021255 Main Street: BISHOP_MADISON_LN Cross Street: N/A Location: S

ADA ID: 44028618C6B9 Ramp Type: Perp Initial Pass/Fail: Fail Overall Compliance: No Severity Score: 25

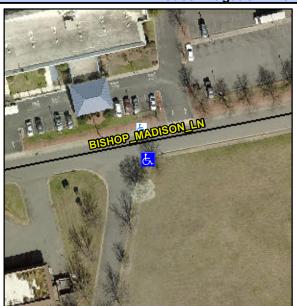
Comp	liance Description	Data	Comp	liance	Description	Data
N/A	Ramp Length (in)	67.0	No	Ramp	Slope (%)	9.1
Yes	Ramp Width (in)	48.0	No	Ramp	XSlope (%)	6.3
N/A	Flare Type LT	N/A	N/A	Flare	Type RT	N/A
N/A	Flare Slope LT (%)	N/A	N/A	Flare	Slope RT (%)	N/A
N/A	Flare Traversable LT?	N/A	N/A	Flare	Traversable RT?	N/A
N/A	Landing Length (in)	N/A	N/A	DWS	Provided?	N/A
N/A	Landing Width (in)	N/A	N/A	DWS	Contrast?	N/A
N/A	Landing Slope (%)	N/A	N/A	DWS	Length (in)	N/A
N/A	Landing X Slope (%)	N/A	N/A	DWS	Full Width?	N/A
N/A	Landing Curb? (Y/N)	N/A	N/A	DWS	Offset (in)	N/A
N/A	Shared Landing?	N/A				
N/A	Gutter Ponding?	N/A	N/A	Gutte	r Slope (%)	N/A
N/A	Gutter Lip Ht (in)	N/A	N/A	Gutte	r X Slope (%)	N/A
N/A	Painted X Walk1?	No	N/A	Painte	ed X Walk2?	N/A
	X Walk 1 Direction	To N		X Wa	lk 2 Direction	N/A
N/A	X Walk 1 Width (in)	N/A	N/A	X Wa	lk 2 Width (in)	N/A
	X Walk 1 Slope (%)	2.6		X Wa	lk 2 Slope (%)	N/A
	X Walk 1 X Slope (%)	4.9		X Wa	lk 2 X Slope (%)	N/A

N/A	Ramp inside XWalk1?	N/A	N/A	Ramp	inside XWalk2?	N/A
	Road Slope (%)	N/A	N/A	Clear	Space?	N/A
	Road X Slope (%)	N/A	N/A	Clear	Space to XWalk (in)	N/A
N/A	Any Obstructions?	N/A	N/A	Storm	n Grate/Utility Hazard?	N/A
	Obstruction Type		l	Storm	n Grate/Utility Type	
		N/A				N/A
			Yes	Surfa	ce Condition? (G/P)	Good

i ossible solution						
Possible Solutions:						
Remove & Replace Entire Ramp.						
Surveyor Notes:						
N/A						
N/A						
PROW/ADA:						
Not Found, R304.2.2, R304.5.3
