# Access Compliance Report

## Public Rights-of-Way

### (Curb Ramps)

| Intersection ID: 42794 | Main Street: SIDNEY_CREST_AV | Cross Street: ERWIN_TRACE_DR | Location: | N |

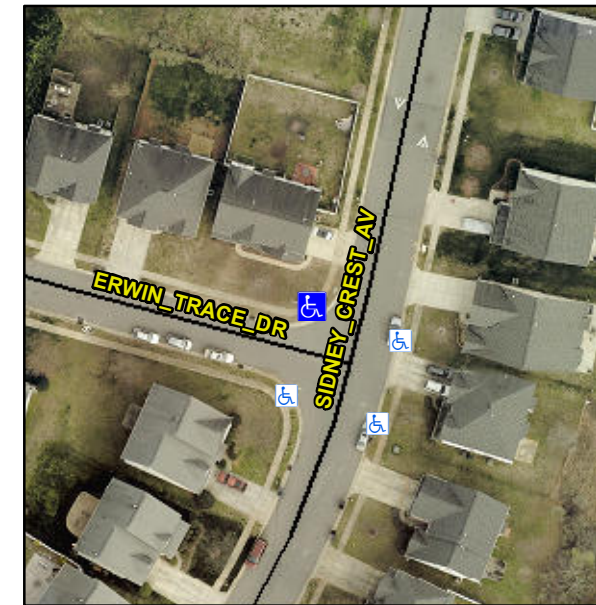
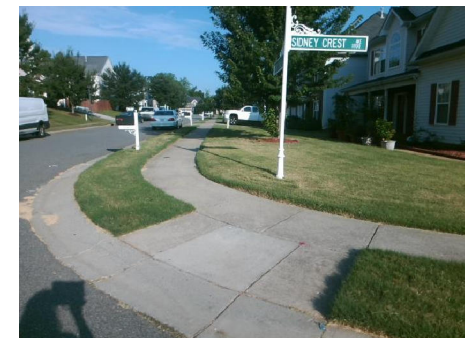
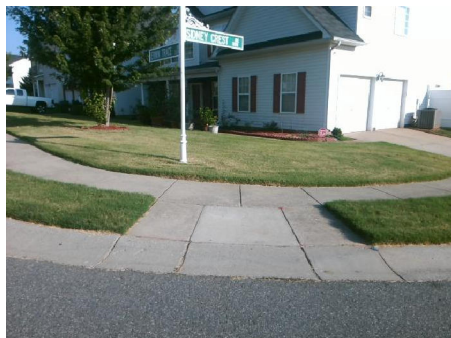
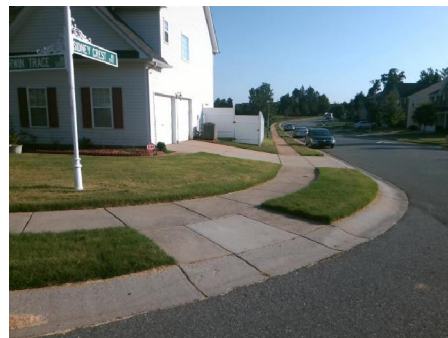
| ADA ID: 440AD082C8E4 | Ramp Type: BlendTrans1 | Initial Pass/Fail: Fail | Overall Compliance: No | Severity Score: 10 |

**Not Found, R304.5.1, R304.5.3**

| Compliance | Description | Data | Compliance | Description | Data |
|---|---|---|---|---|---|
| No | Ramp Width (in) | 41.5 | No | BlendTrans XSlope (%) | 4.1 |
| | | | No | Curb Slope (%) | 16.0 |

**Remove & Replace Curb Ramp With Two New Directional Ramps or Equivalent.**
