Access Compliance Report

Public Rights-of-Way

(Curb Ramps)

Intersection ID: 17457	Main Street: S_WENDOVER_RD	Cross Street: VERNON_DR	Location:	NW
ADA ID: 440BE555313D	Ramp Type: Perp	Initial Pass/Fail: Fail	Overall Compliance: No	Severity Score: 25

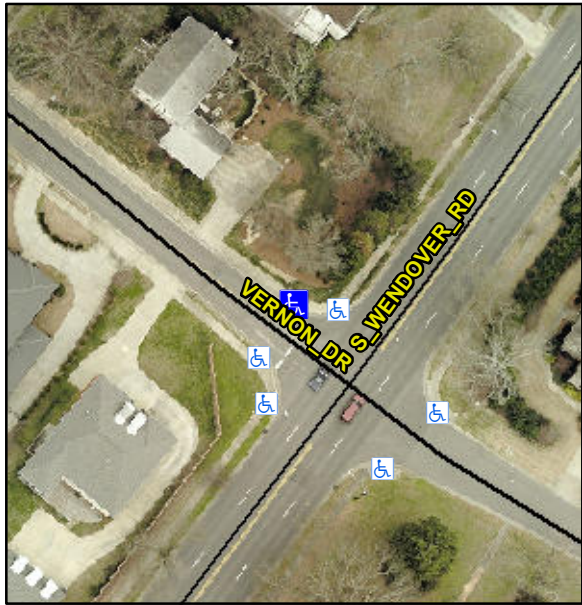
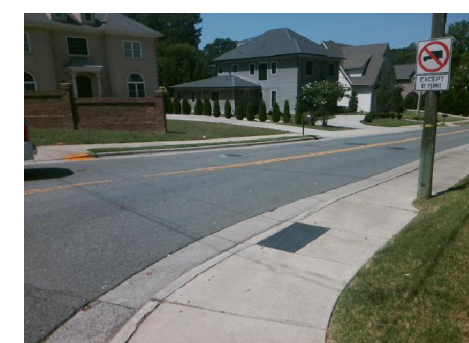
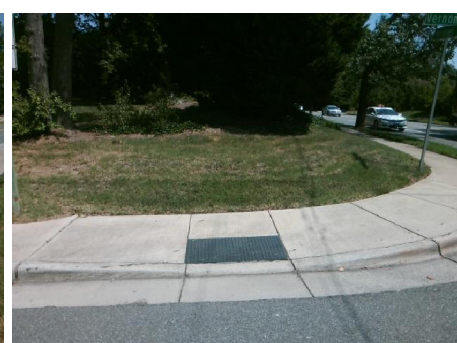
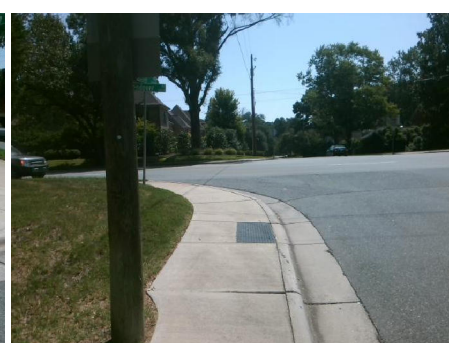
Possible Solutions:		Compliance	Description	Data	Compliance	Description	Data
	Remove & Replace Entire Ramp.		N/A	Ramp Length (in)	60.0	Yes	Ramp Slope (%)	7.4
			Yes	Ramp Width (in)	48.0	No	Ramp XSlope (%)	7.7
			N/A	Flare Type LT	N/A	N/A	Flare Type RT	N/A
			N/A	Flare Slope LT (%)	N/A	N/A	Flare Slope RT (%)	N/A
			N/A	Flare Traversable LT?	N/A	N/A	Flare Traversable RT?	N/A
			N/A	Landing Length (in)	N/A	N/A	DWS Provided?	N/A
			N/A	Landing Width (in)	N/A	N/A	DWS Contrast?	N/A
			N/A	Landing Slope (%)	N/A	N/A	DWS Length (in)	N/A
			N/A	Landing X Slope (%)	N/A	N/A	DWS Full Width?	N/A
Surveyor Notes:			N/A	Landing Curb? (Y/N)	N/A	N/A	DWS Offset (in)	N/A
N/A			N/A	Shared Landing?	N/A			
PROW/ADA:			N/A	Gutter Ponding?	N/A	N/A	Gutter Slope (%)	N/A
Not Found, R304.5.3			N/A	Gutter Lip Ht (in)	N/A	N/A	Gutter X Slope (%)	N/A

N/A	Painted X Walk1?	No	N/A	Painted X Walk2?	N/A
				X Walk 1 Direction	To SW		X Walk 2 Direction	N/A
			N/A	X Walk 1 Width (in)	N/A	N/A	X Walk 2 Width (in)	N/A
				X Walk 1 Slope (%)	3.3		X Walk 2 Slope (%)	N/A
				X Walk 1 X Slope (%)	6.2		X Walk 2 X Slope (%)	N/A
			N/A	Ramp inside XWalk1?	N/A	N/A	Ramp inside XWalk2?	N/A
				Road Slope (%)	N/A	N/A	Clear Space?	N/A
				Road X Slope (%)	N/A	N/A	Clear Space to XWalk (in)	N/A
			N/A	Any Obstructions?	N/A	N/A	Storm Grate/Utility Hazard?	N/A
				Obstruction Type			Storm Grate/Utility Type	
					N/A			N/A
						Yes	Surface Condition? (G/P)	Good
Total Cost:		\$ 1850.00						
Street 1 Name		VERNON DR						
Stop Condition-Street 2		StopSign						
Street 2 Name		N/A						
Stop Condition-Street 1		N/A
