# Access Compliance Report

## Public Rights-of-Way

### (Curb Ramps)

Intersection ID: 10019902	Main Street: ARCO_CORPORATE_DR	Cross Street: N/A	Location: NW
ADA ID: 440BF3930B41	Ramp Type: PerpDiag	Initial Pass/Fail: Fail	Overall Compliance: No
Severity Score: 25			
Codes/Mitigation Info/Possible Solution		Field Measurements/Component Compliance

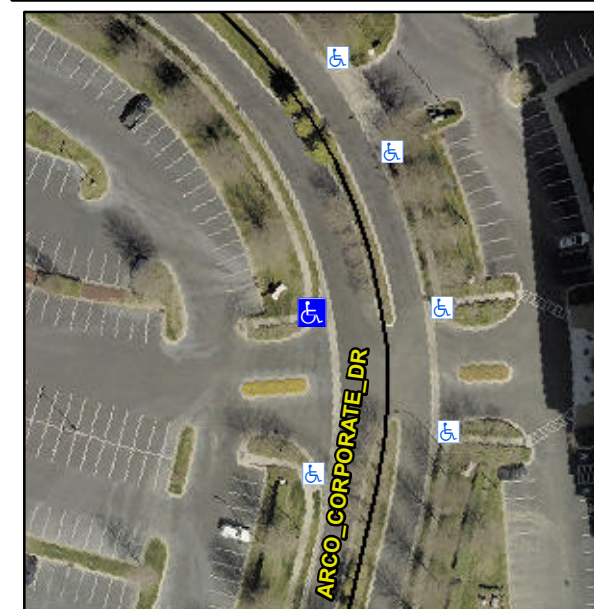
**Not Found, R304.2.2, R304.5.3**

Compliance	Description	Data	Compliance	Description	Data
N/A	Ramp Length (in)	49.0	No	Ramp Slope (%)	8.7
Yes	Ramp Width (in)	48.0	No	Ramp XSlope (%)	5.1
N/A	Flare Type LT	N/A	N/A	Flare Type RT	N/A
N/A	Flare Slope LT (%)	N/A	N/A	Flare Slope RT (%)	N/A
N/A	Flare Traversable LT?	N/A	N/A	Flare Traversable RT?	N/A
N/A	Landing Length (in)	N/A	N/A	DWS Provided?	N/A
N/A	Landing Width (in)	N/A	N/A	DWS Contrast?	N/A
N/A	Landing Slope (%)	N/A	N/A	DWS Length (in)	N/A
N/A	Landing X Slope (%)	N/A	N/A	DWS Full Width?	N/A
N/A	Landing Curb? (Y/N)	N/A	N/A	DWS Offset (in)	N/A
N/A	Shared Landing?	N/A			
N/A	Gutter Ponding?	N/A	N/A	Gutter Slope (%)	N/A
N/A	Gutter Lip Ht (in)	N/A	N/A	Gutter X Slope (%)	N/A
N/A	Painted X Walk1?	No	N/A	Painted X Walk2?	No
	X Walk 1 Direction	To SW		X Walk 2 Direction	To E
N/A	X Walk 1 Width (in)	N/A	N/A	X Walk 2 Width (in)	N/A
	X Walk 1 Slope (%)	5.6		X Walk 2 Slope (%)	2.8
	X Walk 1 X Slope (%)	0.9		X Walk 2 X Slope (%)	4.7

N/A	Ramp inside XWalk1?	N/A	N/A	Ramp inside XWalk2?	N/A
	Road Slope (%)	5.8	N/A	Clear Space?	N/A
	Road X Slope (%)	2.4	N/A	Clear Space to XWalk (in)	N/A
N/A	Any Obstructions?	N/A	N/A	Storm Grate/Utility Hazard?	N/A
	Obstruction Type			Storm Grate/Utility Type	
		N/A			N/A
			Yes	Surface Condition? (G/P)	Good

**Remove & Replace Curb Ramp With Two New Directional Ramps or Equivalent.**
