Access Compliance Report

Public Rights-of-Way

(Curb Ramps)

Intersection ID: 45184	Main Street: HOLDEN_CT	Cross Street: TORRELLE_DR	Location: SW
ADA ID: 440C5F66FCE2	Ramp Type: BlendTrans1	Initial Pass/Fail: Fail	Overall Compliance: No
Severity Score: 25			
Codes/Mitigation Info/Possible Solution		Field Measurements/Component Compliance

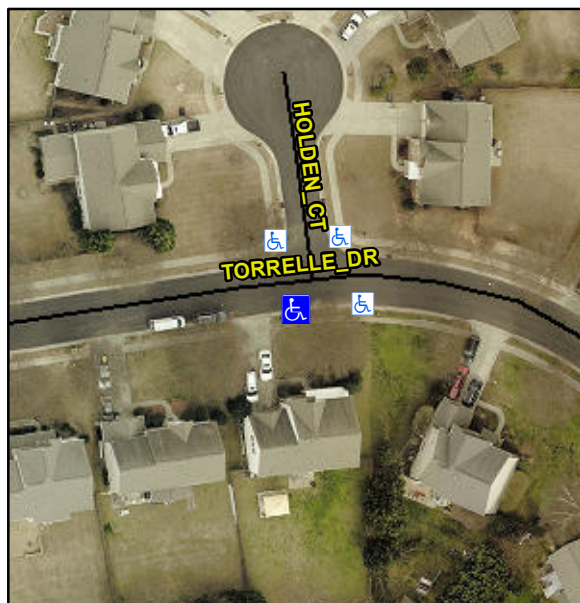
Not Found, R304.5.3

Compliance	Description	Data	Compliance	Description	Data
N/A	Ramp Length (in)	47.0	Yes	BlendTrans Slope (%)	4.0
Yes	Ramp Width (in)	58.0	No	BlendTrans XSlope (%)	7.1
N/A	Flare Type LT	N/A	N/A	Flare Type RT	N/A
N/A	Flare Slope LT (%)	N/A	N/A	Flare Slope RT (%)	N/A
N/A	Flare Traversable LT?	N/A	N/A	Flare Traversable RT?	N/A
N/A	Landing Length (in)	N/A	N/A	DWS Provided?	N/A
N/A	Landing Width (in)	N/A	N/A	DWS Contrast?	N/A
N/A	Landing Slope (%)	N/A	N/A	DWS Length (in)	N/A
N/A	Landing X Slope (%)	N/A	N/A	DWS Full Width?	N/A
N/A	Landing Curb? (Y/N)	N/A	N/A	DWS Offset (in)	N/A
N/A	Shared Landing?	N/A			
N/A	Gutter Ponding?	N/A	N/A	Gutter Slope (%)	N/A
N/A	Gutter Lip Ht (in)	N/A	N/A	Gutter X Slope (%)	N/A
N/A	Painted X Walk1?	No	N/A	Painted X Walk2?	N/A
	X Walk 1 Direction	To N		X Walk 2 Direction	N/A
	X Walk 1 Width (in)	N/A		X Walk 2 Width (in)	N/A
	X Walk 1 Slope (%)	0.9		X Walk 2 Slope (%)	N/A
	X Walk 1 X Slope (%)	1.3		X Walk 2 X Slope (%)	N/A

N/A	Ramp inside XWalk1?	N/A	N/A	Ramp inside XWalk2?	N/A
	Road Slope (%)	1.3		Clear Space?	N/A
	Road X Slope (%)	0.9	N/A	Clear Space to XWalk (in)	N/A
N/A	Any Obstructions?	N/A	N/A	Storm Grate/Utility Hazard?	N/A
	Obstruction Type			Storm Grate/Utility Type	
		N/A			N/A
			Yes	Surface Condition? (G/P)	Good
			No	Curb Slope (%)	13.4

Possible Solutions:

Remove & Replace Curb Ramp With Two New Directional Ramps or Equivalent.
